**CONDITION SURVEY REPORT
FOR
WEATHERPROOF EXTERNAL FALSE CEILING SYSTEM
AT PODIUM LEVEL OF THE BELCHER'S
NO 89 POK FU LAM ROAD
HONGKONG**

Report Prepared by
Savills Project Consultancy Limited

Survey Date: 15 MARCH 2019, 21 MARCH 2019, 22 MARCH 2019

Report date: 24 APRIL 2019

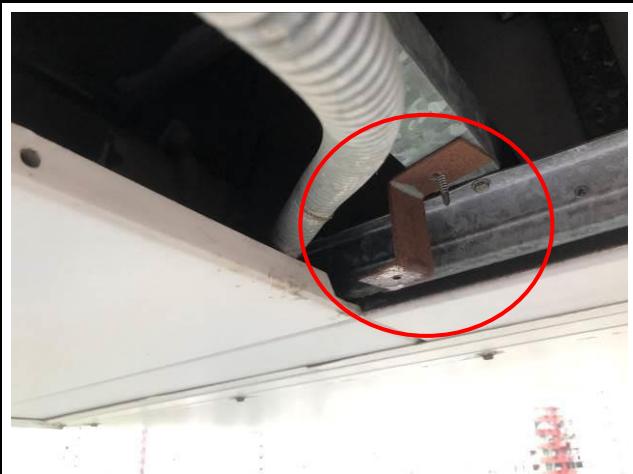
I) Rusty brackets connecting ceiling grid and access panel	A4, A12, A15, A25, A29, A40, A45, B4, B5, B14, B23, B34, B58, B64, C7, C13, C19, C21, C34, C40, C48, C55, C58, C65

Photo No. A4 Bracket connecting grid and access panel was rusty.

- 1) Patch repair
 - a. Remove rusty stains on reachable steel members and apply one coat of galvanized paint on surfaces.
 - b. Re-install damaged ceiling grids.
 - c. Replace missing aluminum ceiling panels to match adjacent areas.

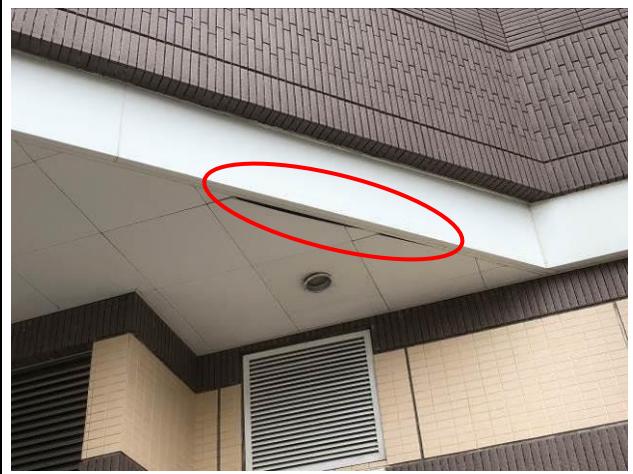
B) Damaged ceiling grids with screws remaining	B39, B40
C) Damaged ceiling panels forming gap	A6, A13, C68
D) Rusty ceiling grids	A34, B12, B13, B14, B15, B36, B37, B42, B58, B59, C38, C49, C59

Photo No. A6 Damaged ceiling panels forming gap.

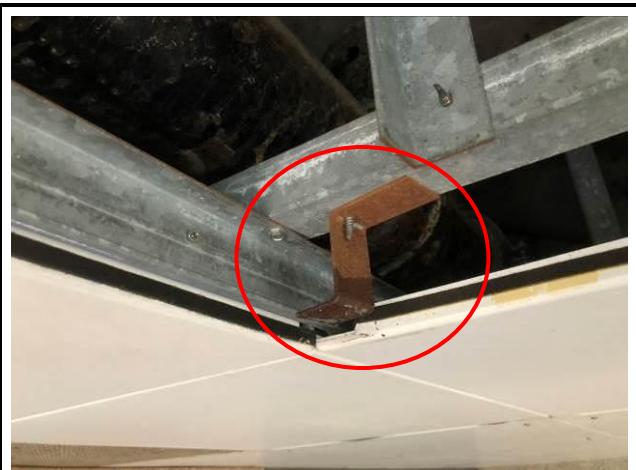
Photo No. A12 | Bracket connecting grid and access panel was rusty.

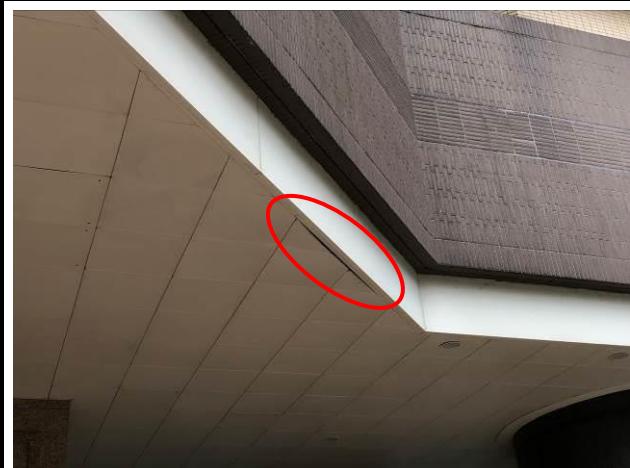
Photo No. A13 | Damaged ceiling panels forming gap.

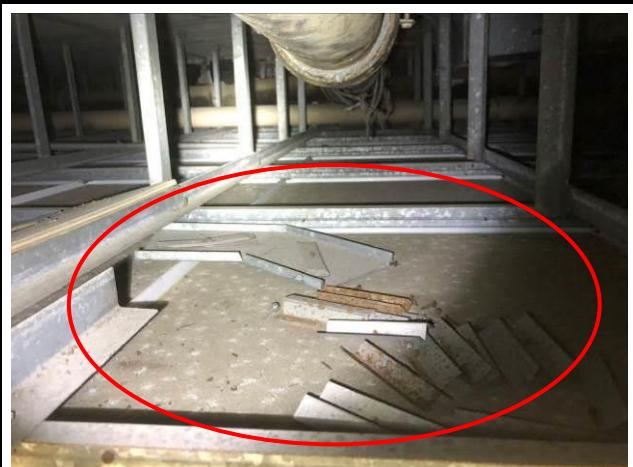
L) Rusty screws	A46, B28, C58, C64, C65
M) Defective weld joint	A32
N) Unused materials and debris on ceiling panels	A18, B57, C10, C11, C22, C37, C57

Photo No. A18 | Unused materials were found on panels.

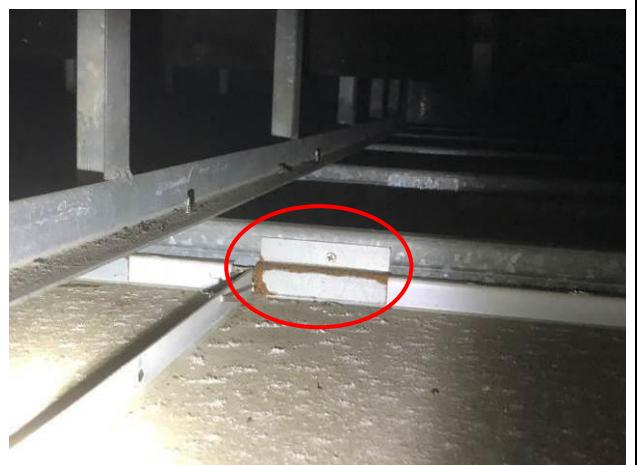
J) Rusty brackets connecting ceiling grid and ceiling panel	A22, A37, B6, B20, B27, B35, B44, B52, C5, C23, C34, C47, C54, C63, C64
K) Rusty welded joints due to missing of galvanized paint	A16, A17, A19, A24, B19, B25, B26, B29, B41, B43, B53, C12, C39, C53

Photo No. A22 | Bracket connecting grid and ceiling panel was rusty.

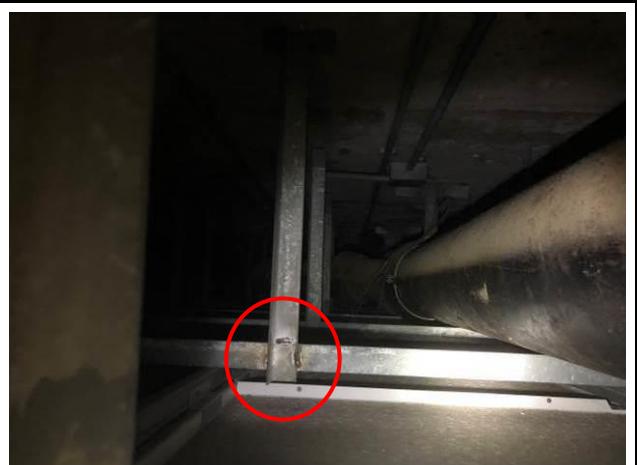
Photo No. A24 | Welded joints were rusty.

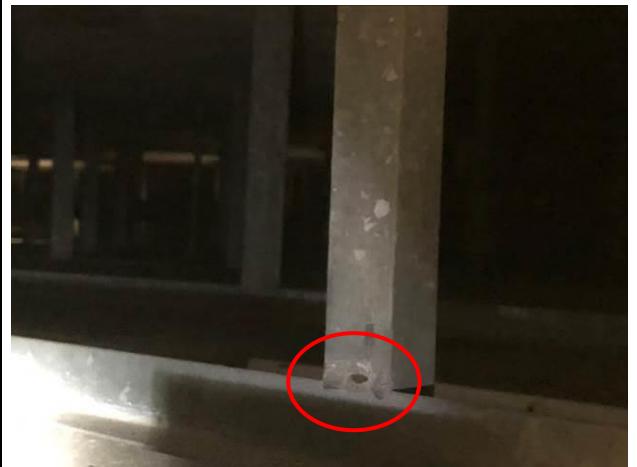
Photo No. A32 Hole was found on weld joint.

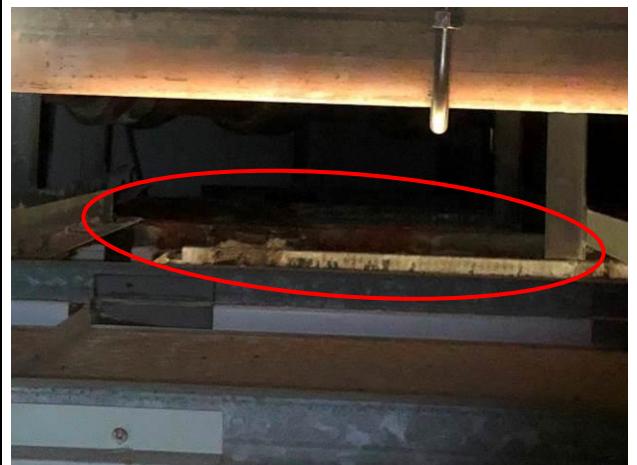
Photo No. A34 Ceiling grid was rusty.

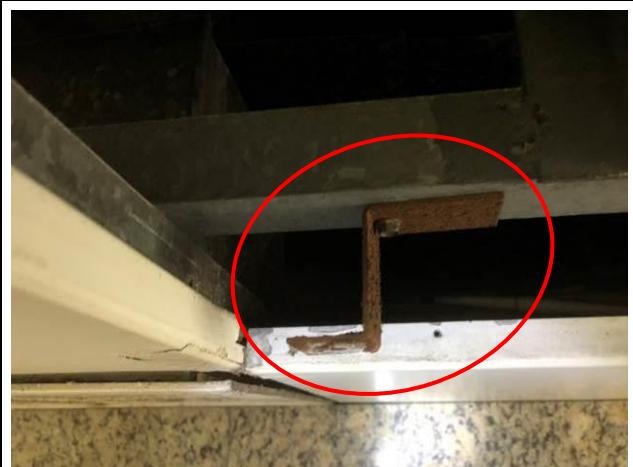
Photo No. A40 | Bracket connecting grid and access panel was rusty.

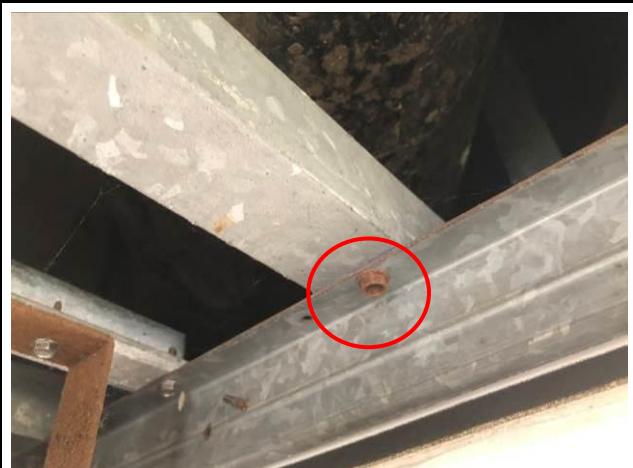
Photo No. A46 Screw was rusty.

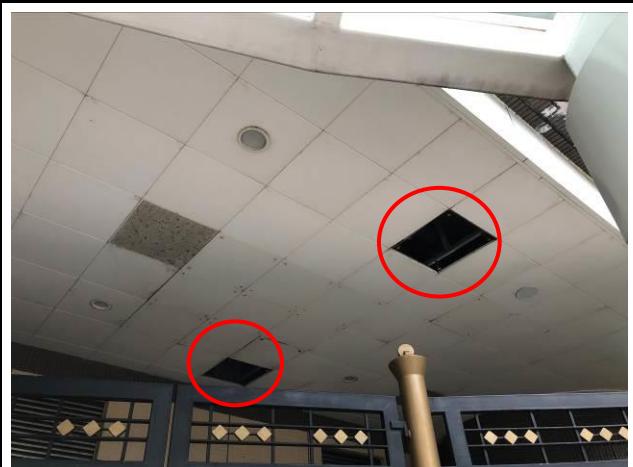
Defects	Photo No. Ref.
A) Missing ceiling panels possibly due to typhoon (total 103 pieces of ceiling panels missing; area approx. 40m ²)	A27, A41, A48, A50, B16, B30, B47, B48, B49, B54, B55, B66, B68, B69, C14, C27, C28, C29, C41, C42, C43, C44, C50

Photo No. A48 2 pieces of ceiling panels were missing.

Patch repair should be treated as the short-term remedial measure of the entire maintenance works. As the Ceiling System is a closed space design, missing ceiling panels would form gaps and reduce the effectiveness to withstand strong wind. The undermentioned approaches would spend much more time and it is not an easy way to solve the root cause. The Pacific Typhoon Season would approach in summer and there is an urgent need to replace and install new aluminum ceiling panels to seal the gaps.

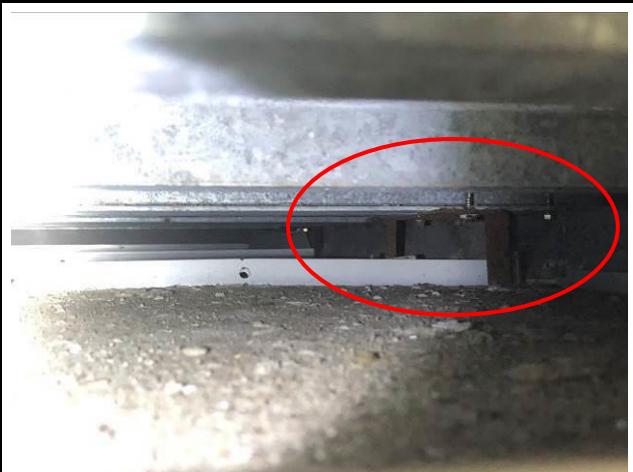
Photo No. B4 Bracket connecting grid and access panel was rusty.

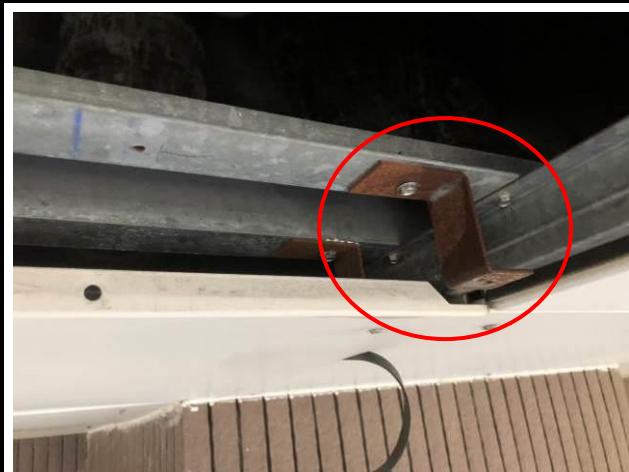
Photo No. B5 Bracket connecting grid and access panel was rusty.

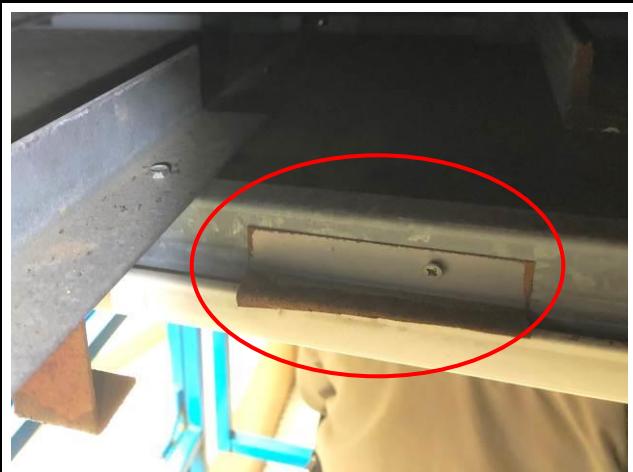
Photo No. B6 Bracket connecting grid and ceiling panel was rusty.

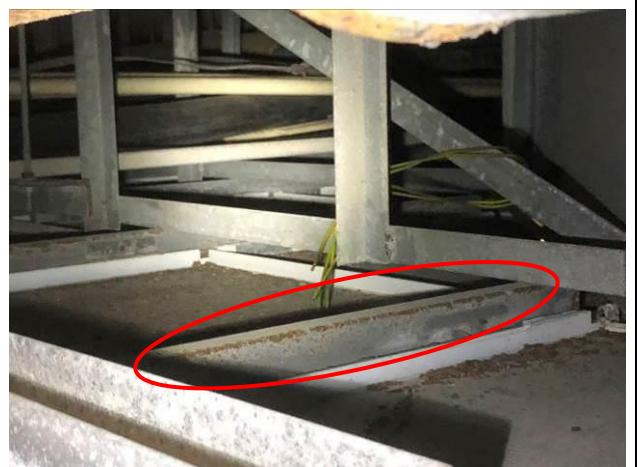
Photo No. B12 Ceiling grid was rusty.

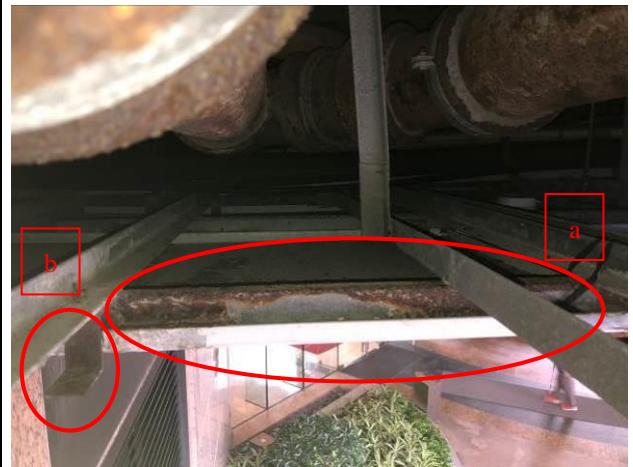
Photo No. B14 a) Ceiling grid was rusty.
b) Bracket connecting grid and access panel was rusty.

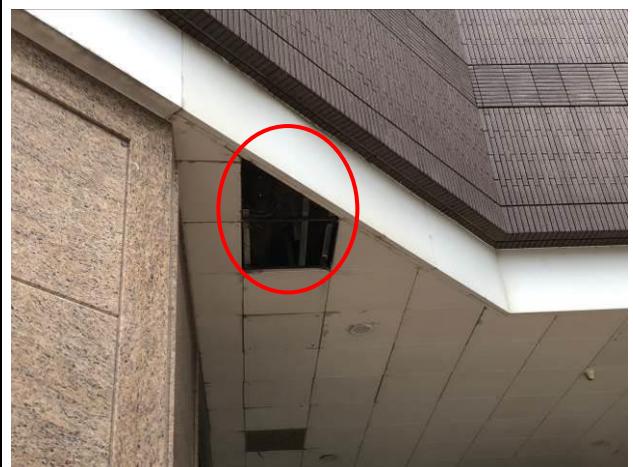
Photo No. B16 2 pieces of ceiling panel were missing

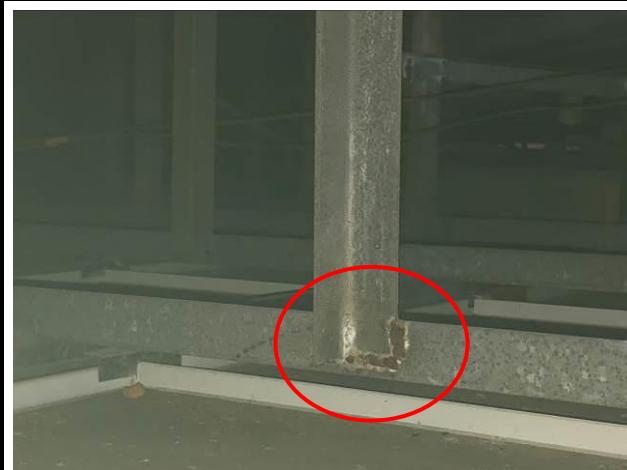
Photo No. B19 Welded joints were rusty.

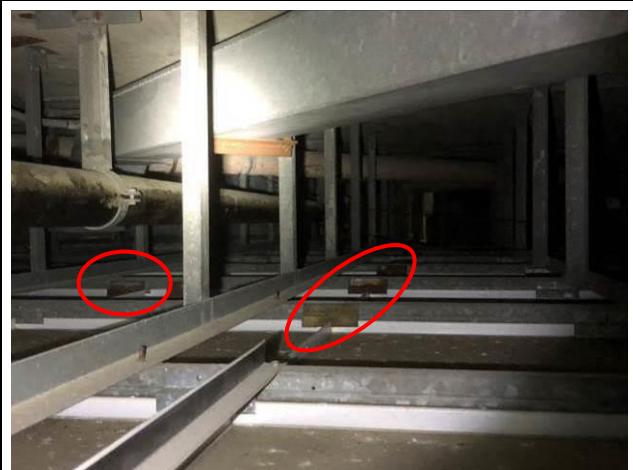
Photo No. B20 Brackets connecting grid and ceiling panel were rusty.

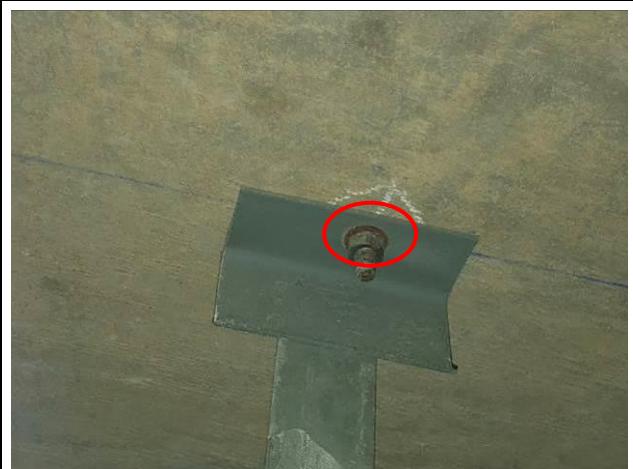
E) Discrete ceiling grids	C31, C32
F) Missing screws on GMS plates	C26
G) Rusty bolts and washer plates	B22, B46, C33
H) Rusty GMS plates and GMS posts	B29, B46, C6, C24, C26, C33

Photo No. B22 Washer plate was rusty.

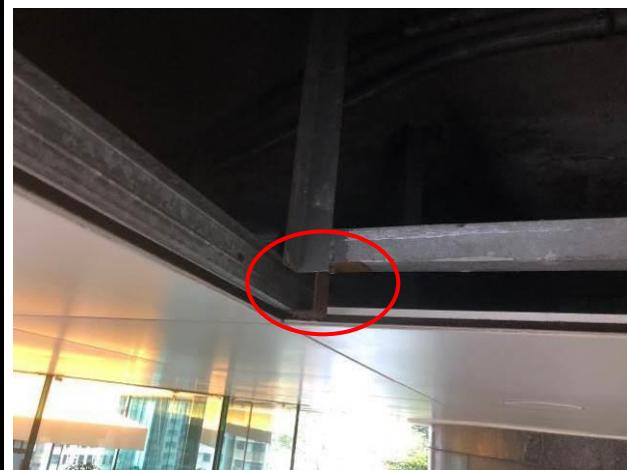
Photo No. B23 Bracket connecting grid and access panel was rusty.

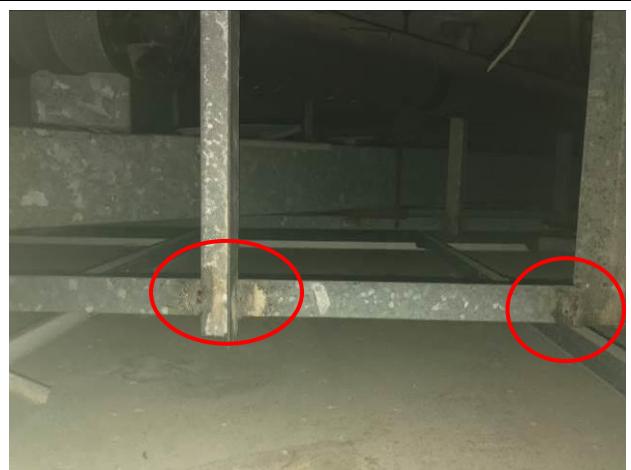
Photo No. B26 | Welded joints were rusty.

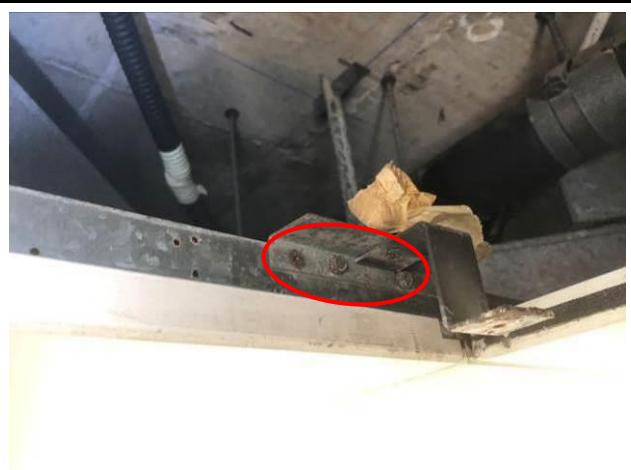
Photo No. B28 | Screws were rusty

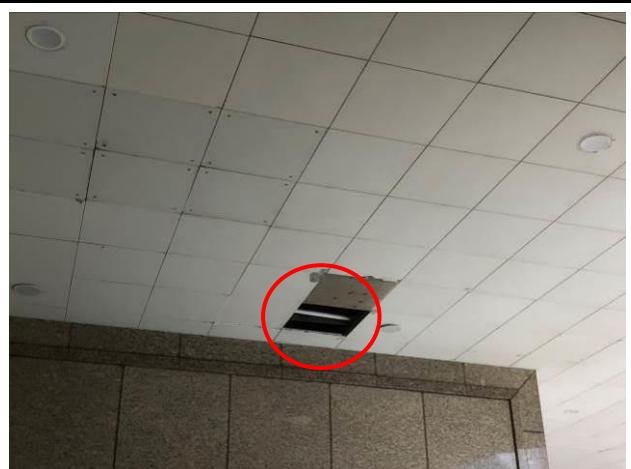
Photo No. B30 | 1 piece of ceiling panel was missing

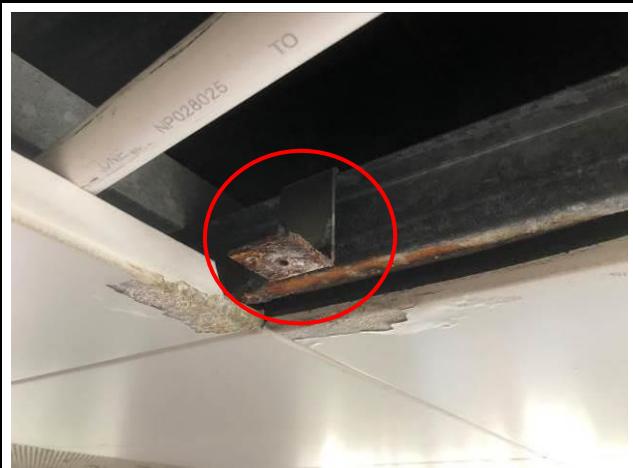
Photo No. B34 Bracket connecting grid and access panel was rusty.

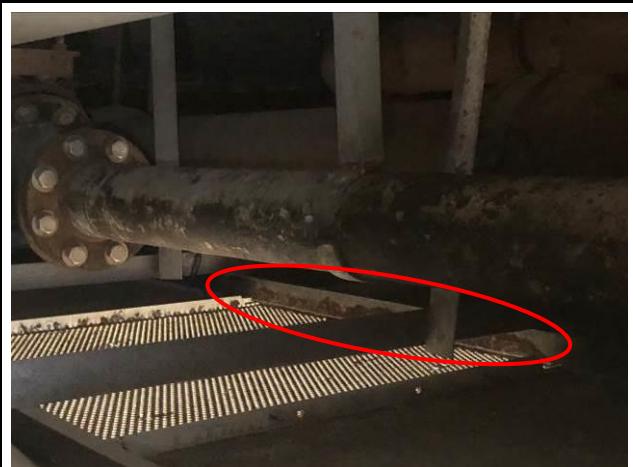
Photo No. B36 Ceiling grid was rusty.

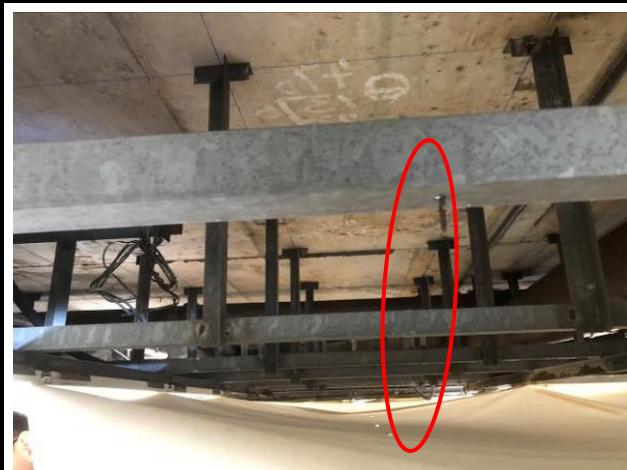
Photo No. B39 | Ceiling grids were damaged with screws remaining.

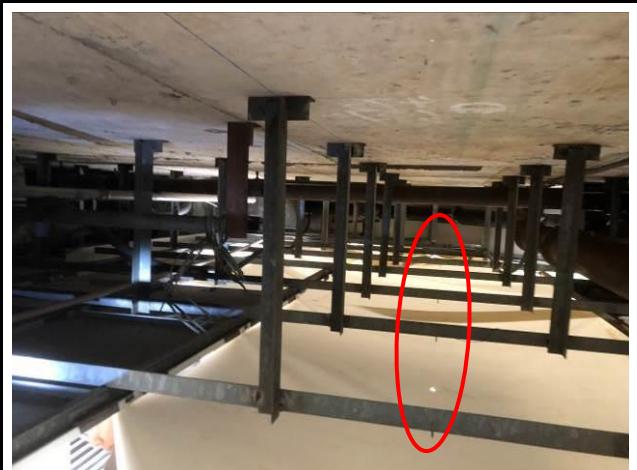
Photo No. B40 | Ceiling grids were damaged with screws remaining.

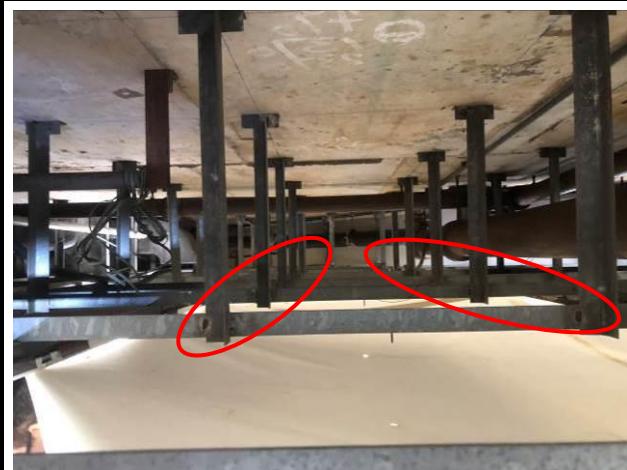
Photo No. B41 | Welded joints were rusty.

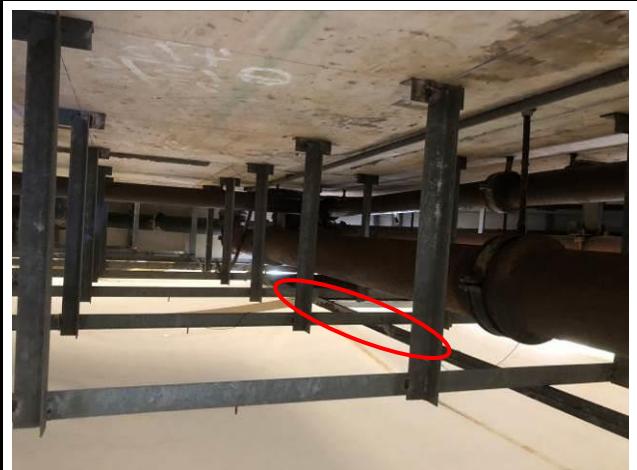
Photo No. B42 | Ceiling grid was rusty.

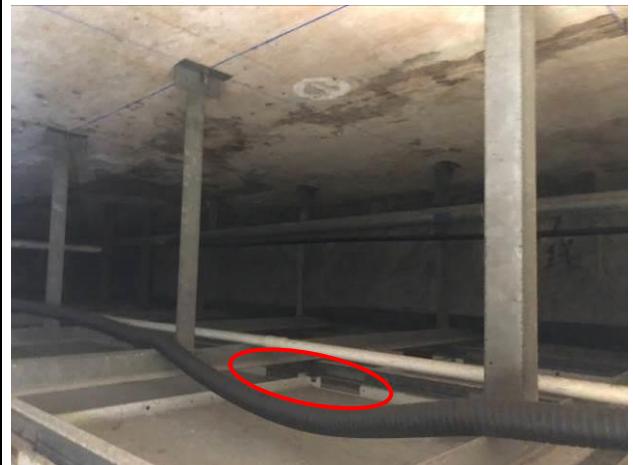
Photo No. B44 Brackets connecting grid and ceiling panel were rusty.

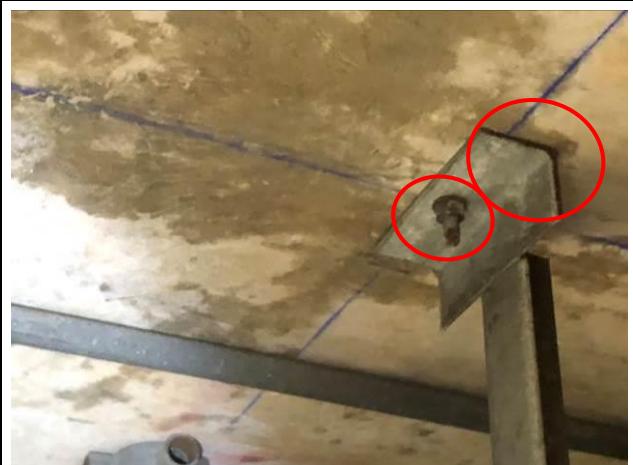
Photo No. B46 a) Bolt was rusty.
b) Edge of GMS plate was rusty.

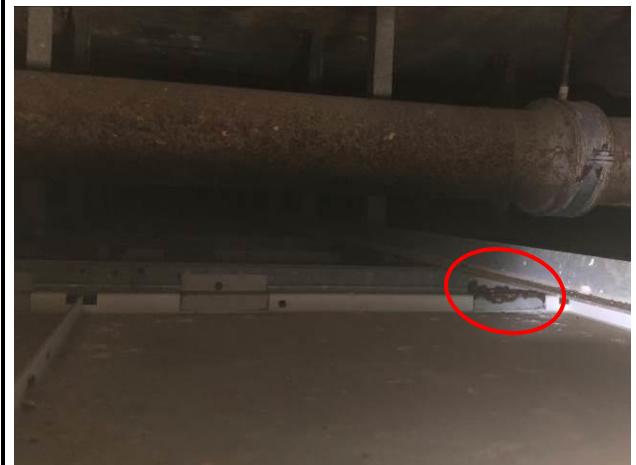
Photo No. B52 Bracket connecting grid and ceiling panel was rusty.

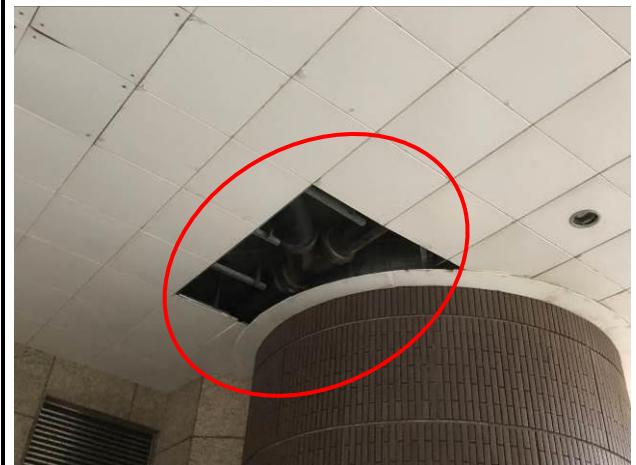
Photo No. B54 5 pieces of ceiling panel were missing.

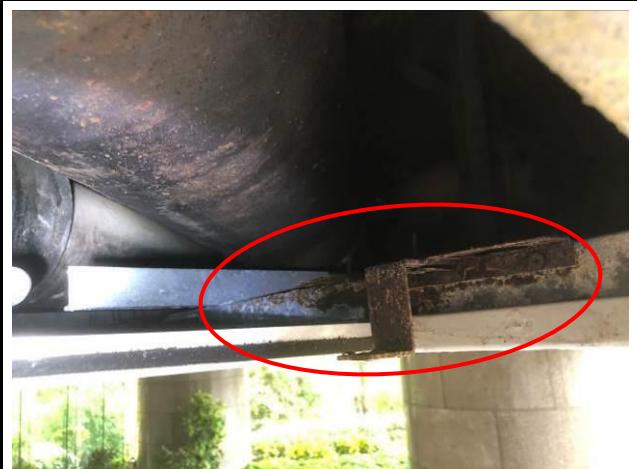
Photo No. B58 Ceiling grid and bracket were rusty.

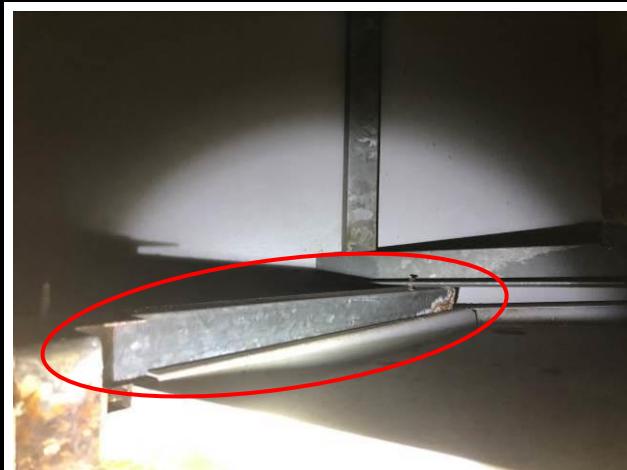
Photo No. B59 Ceiling grid was inclined and rusty.

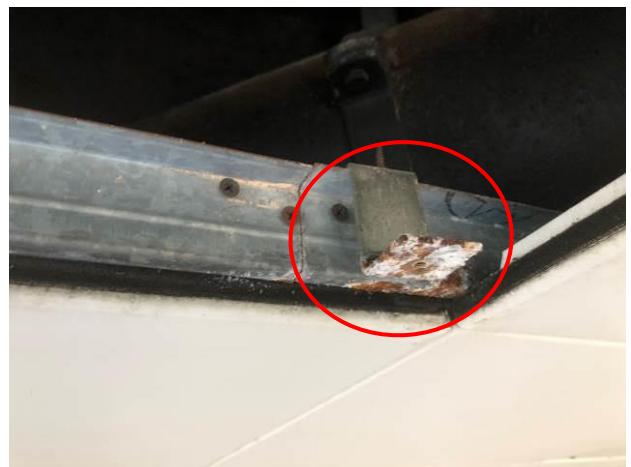
Photo No. B64 Bracket connecting grid and access panel was rusty.

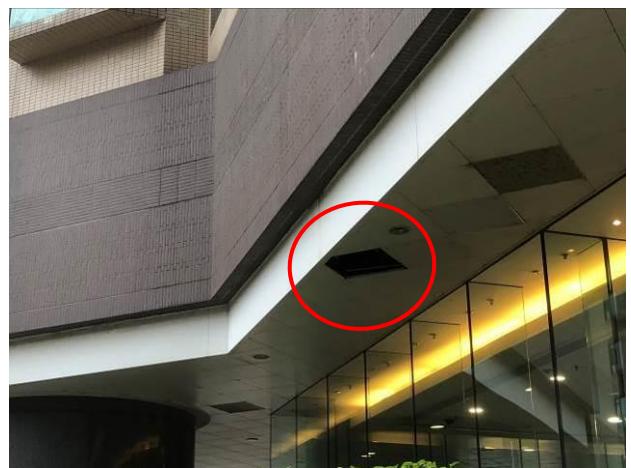
Photo No. B66 1 piece of ceiling panel was missing.

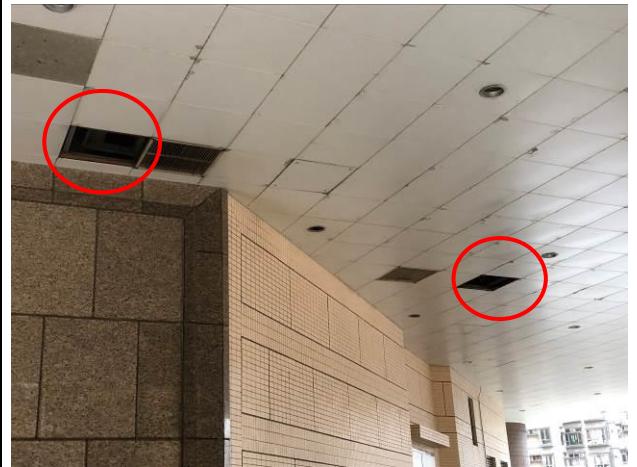
Photo No. C14 | 2 pieces of ceiling panels were missing.

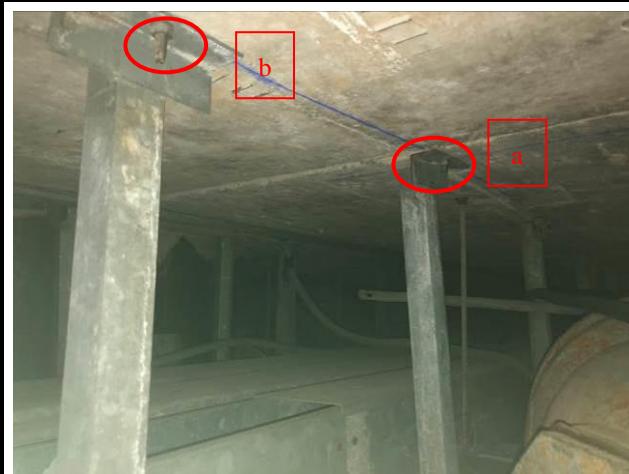
Photo No. C33 a) GMS plate was rusty.
b) Bolt was rusty.

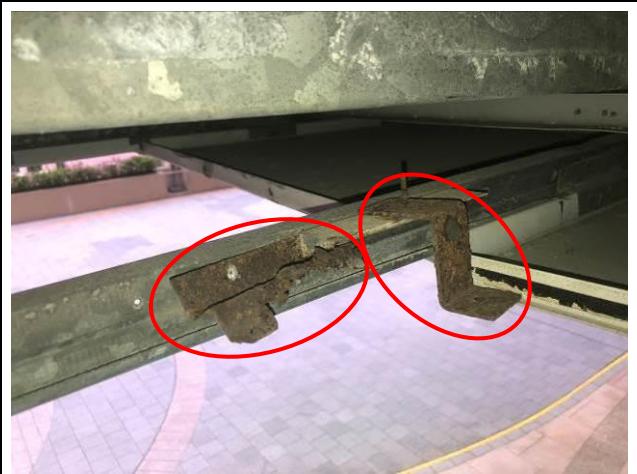
Photo No. C34 Brackets connecting grid and access panel/ panels were rusty and corroded.

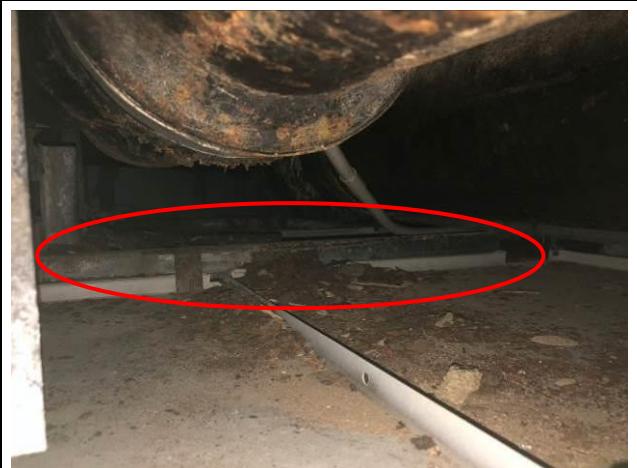
Ceiling grid was rusty.

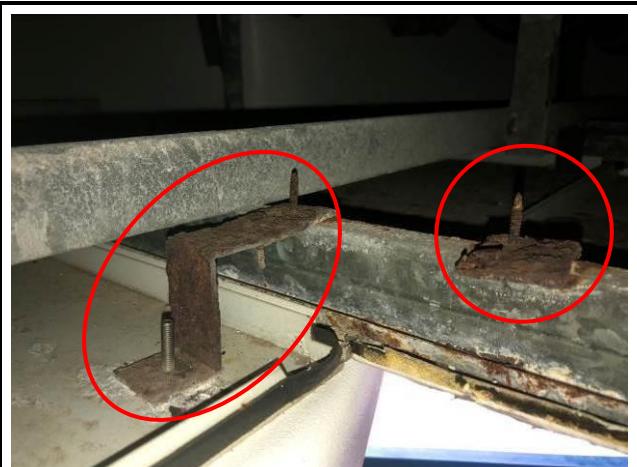
Brackets connecting grid and access panel were rusty.

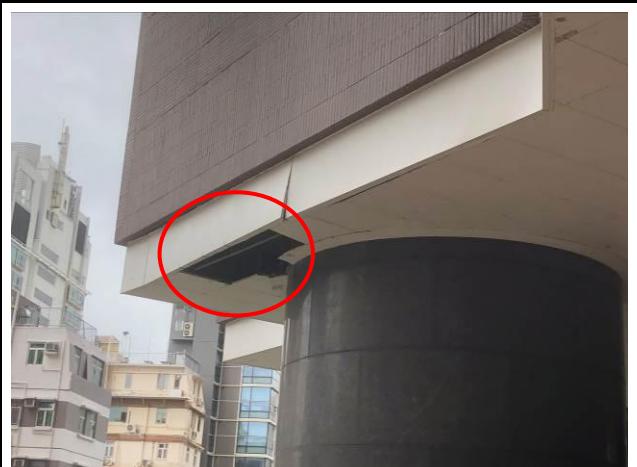
3 pieces of ceiling panels were missing.

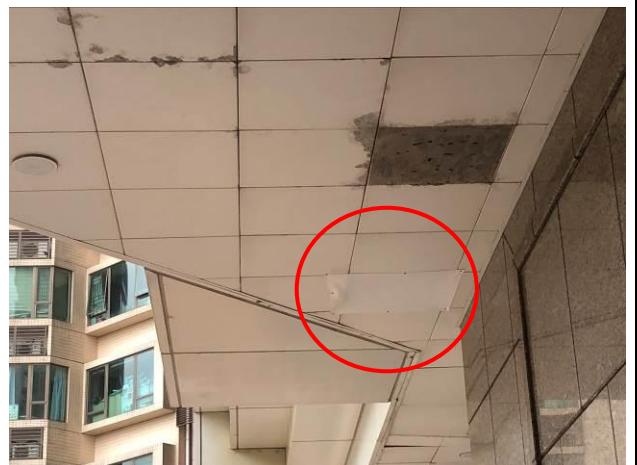
1 piece of ceiling panel was missing.

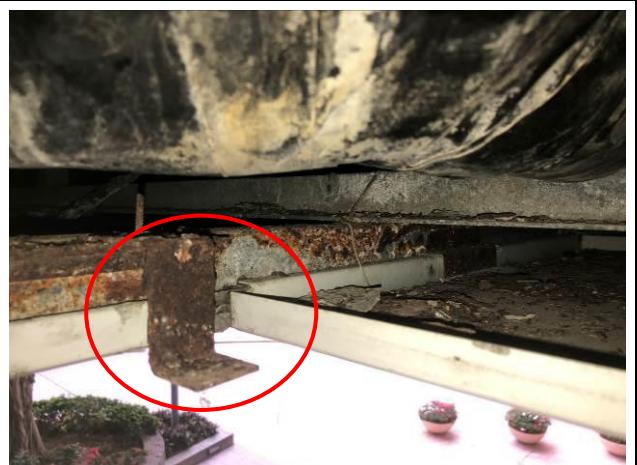
Bracket connecting grid and access panel was rusty.

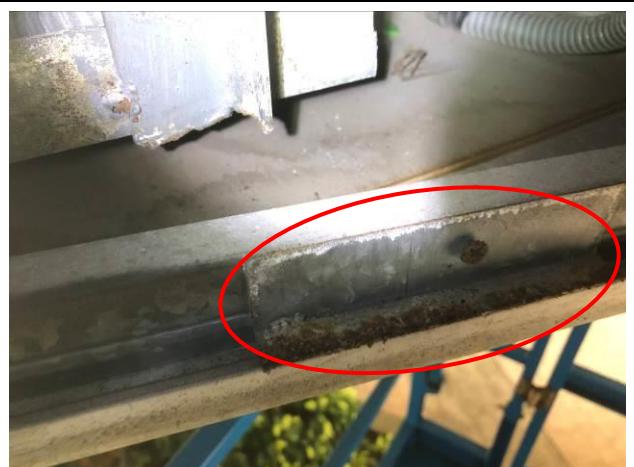
Photo No. C64 Bracket connecting grid and access panel and screw were rusty.
