**CONDITION SURVEY REPORT
FOR
WEATHERPROOF EXTERNAL FALSE CEILING SYSTEM
AT PODIUM LEVEL OF THE BELCHER'S
NO 89 POK FU LAM ROAD
HONGKONG**

Report Prepared by
Savills Project Consultancy Limited

Survey Date: 15 MARCH 2019, 21 MARCH 2019, 22 MARCH 2019

Report date: 24 APRIL 2019

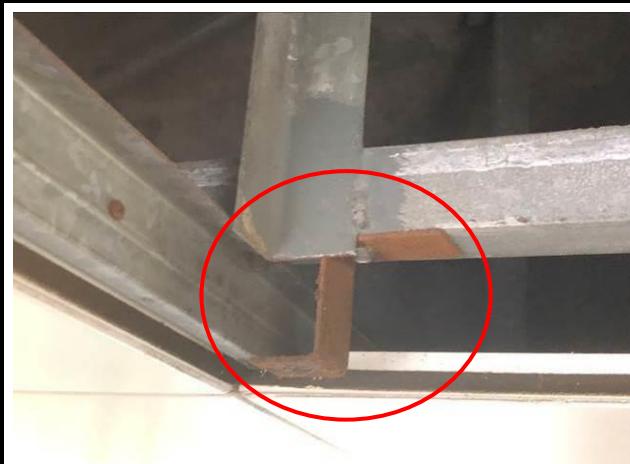
I) Rusty brackets connecting ceiling grid and access panel	A4, A12, A15, A25, A29, A40, A45, B4, B5, B14, B23, B34, B58, B64, C7, C13, C19, C21, C34, C40, C48, C55, C58, C65

Photo No. A15 | Bracket connecting grid and access panel was rusty.

- 1) Patch repair
 - a. Remove rusty stains on reachable steel members and apply one coat of galvanized paint on surfaces.
 - b. Re-install damaged ceiling grids.
 - c. Replace missing aluminum ceiling panels to match adjacent areas.

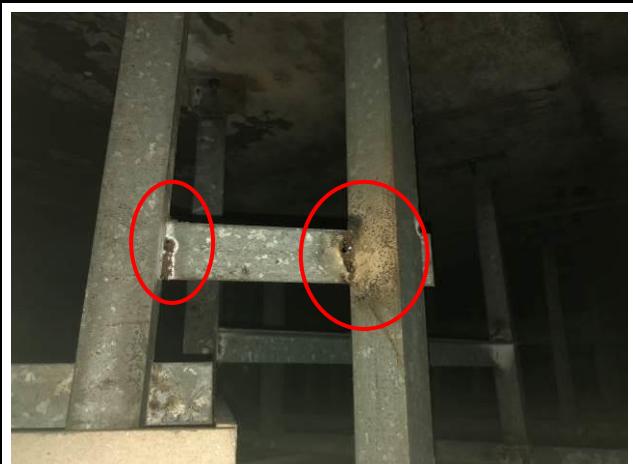
J) Rusty brackets connecting ceiling grid and ceiling panel	A22, A37, B6, B20, B27, B35, B44, B52, C5, C23, C34, C47, C54, C63, C64
K) Rusty welded joints due to missing of galvanized paint	A16, A17, A19, A24, B19, B25, B26, B29, B41, B43, B53, C12, C39, C53

Photo No. A16 | Welded joints were rusty.

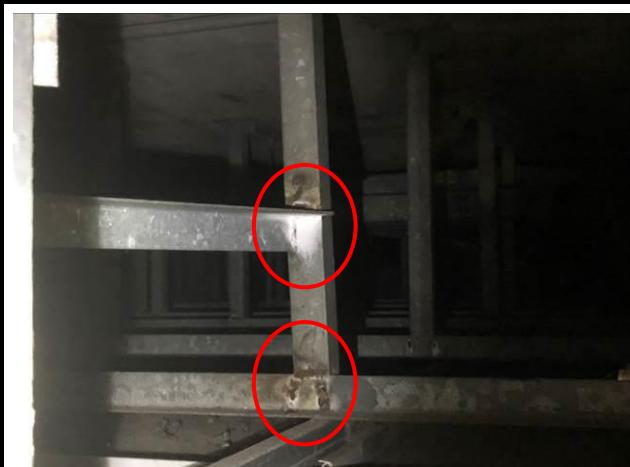
Photo No. A17 | Welded joints were rusty.

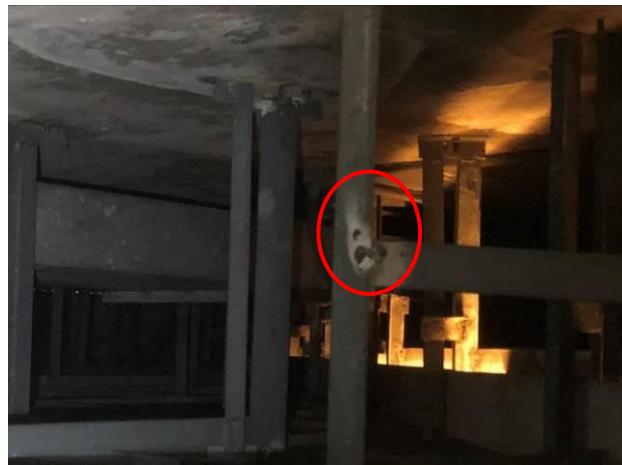
Photo No. A19 | Welded joints were rusty.

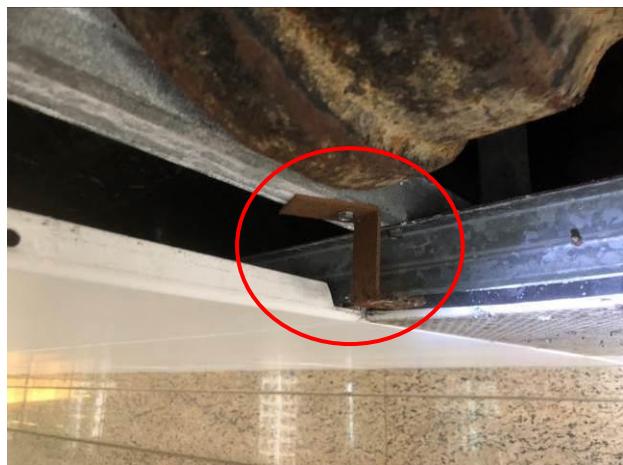
Photo No. A25 Bracket connecting grid and access panel was rusty.

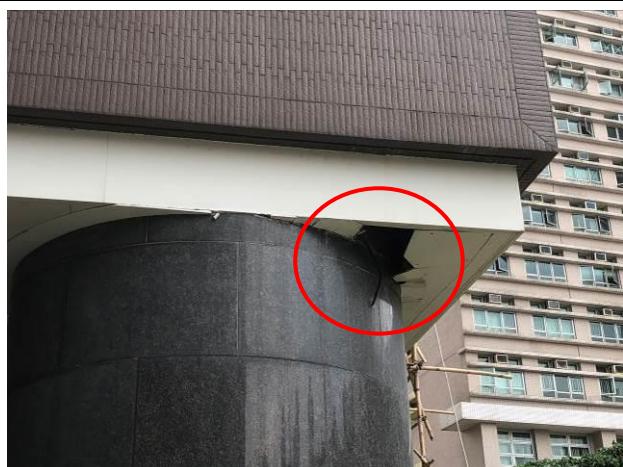
Defects	Photo No. Ref.
A) Missing ceiling panels possibly due to typhoon (total 103 pieces of ceiling panels missing; area approx. 40m ²)	A27, A41, A48, A50, B16, B30, B47, B48, B49, B54, B55, B66, B68, B69, C14, C27, C28, C29, C41, C42, C43, C44, C50

Photo No. A27 1 piece of ceiling panel was missing

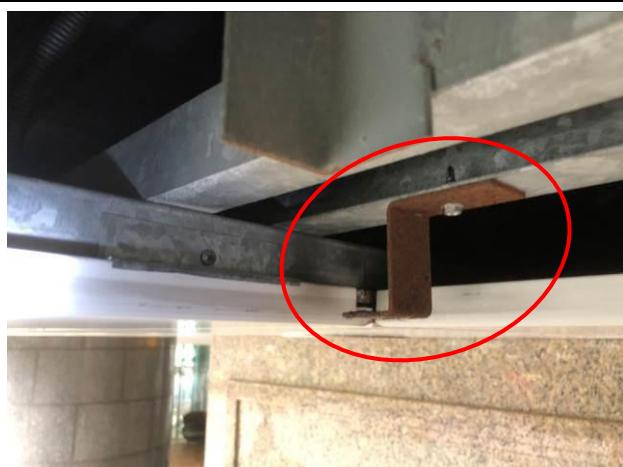
Photo No. A29 Bracket connecting grid and access panel was rusty.

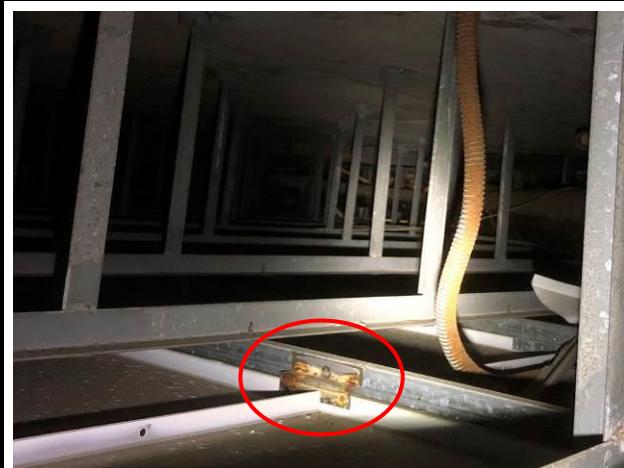
Photo No. A37 | Bracket connecting grid and ceiling panel was rusty.

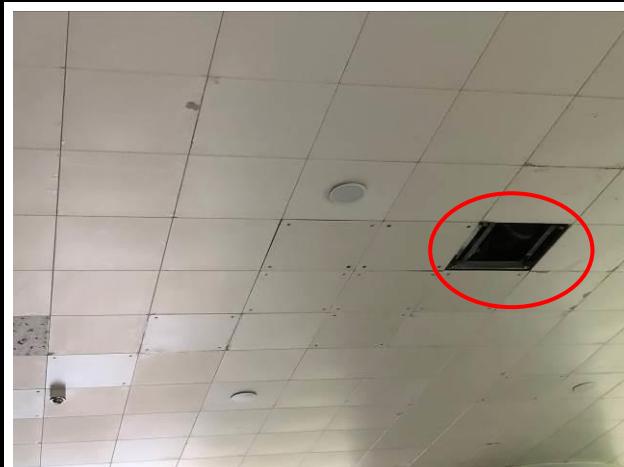
Photo No. A41 | 1 piece of ceiling panel was missing.

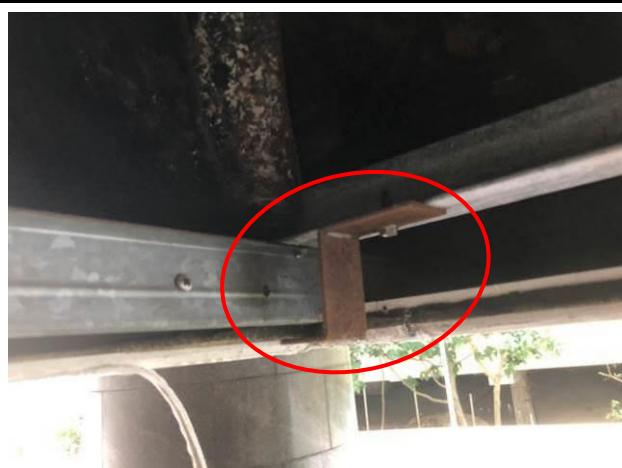
Photo No. A45 Bracket connecting grid and access panel was rusty.

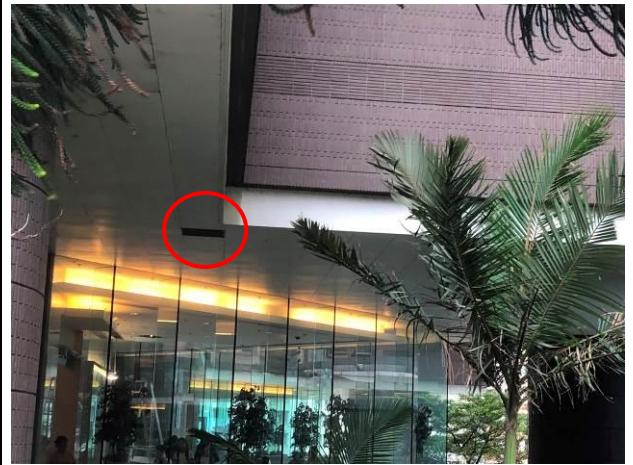
Photo No. A49	Area inaccessible by scissor platform	Photo No. A50	1 piece of ceiling panel was missing.
---------------	---------------------------------------	---------------	---------------------------------------

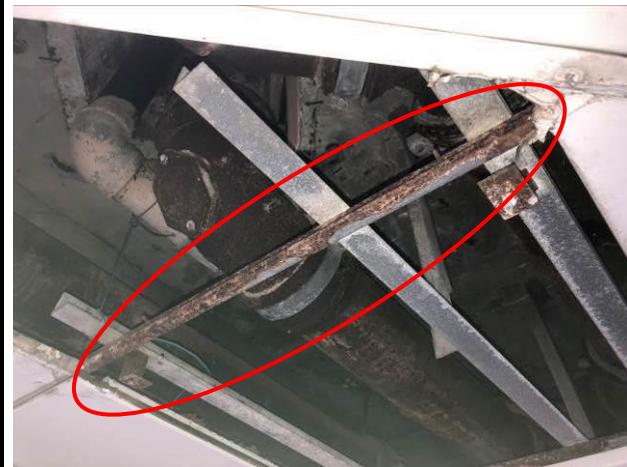
Photo No. B13 Ceiling grid was rusty.

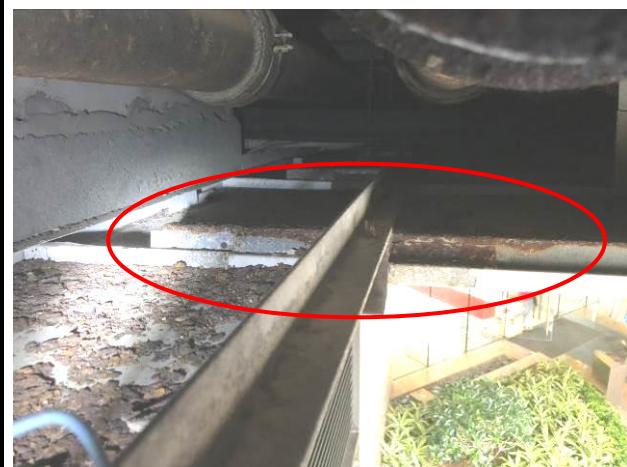
Photo No. B15 Ceiling grid was rusty.

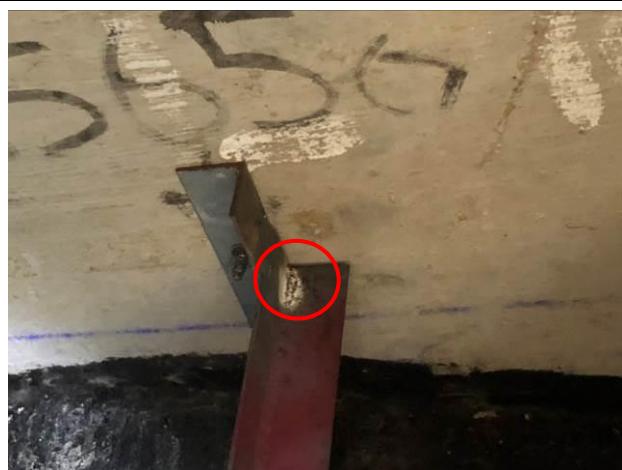
Photo No. B25 | Welded joints were rusty.

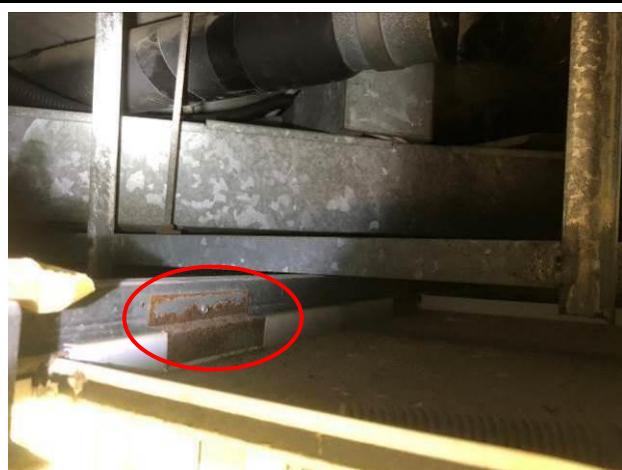
Photo No. B27 | Bracket connecting grid and ceiling panel was rusty.

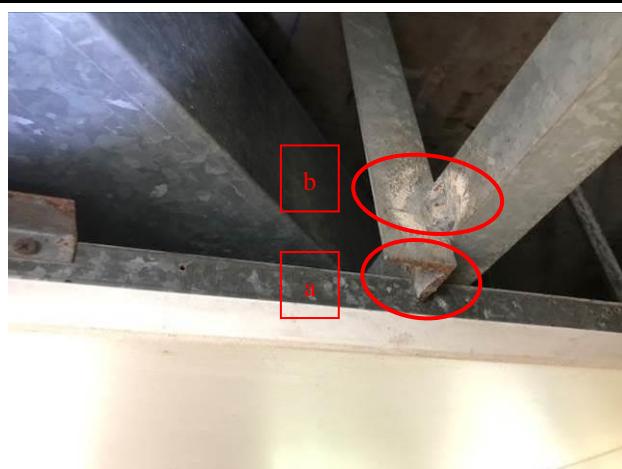
Photo No. B29 | a) Edge of GMS post was rusty.
b) Welded joints were rusty.

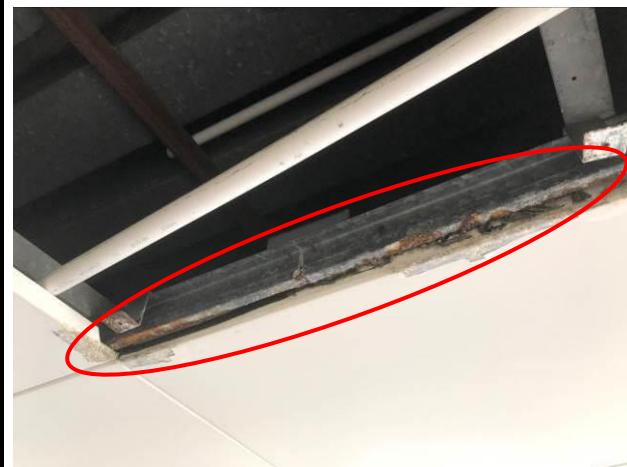
Photo No. B37 | Ceiling grid was rusty.

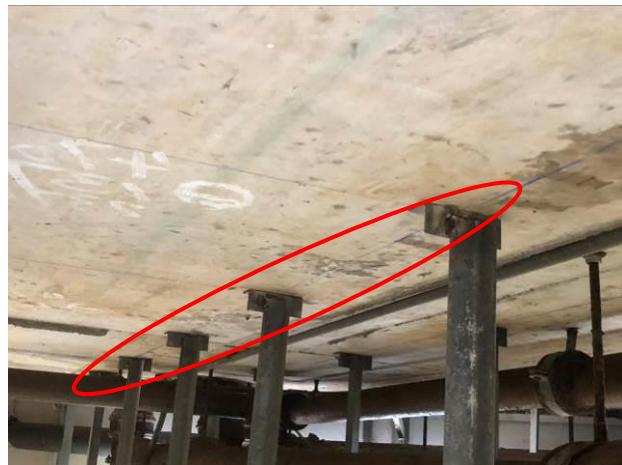
Photo No. B43 Welded joints were rusty.

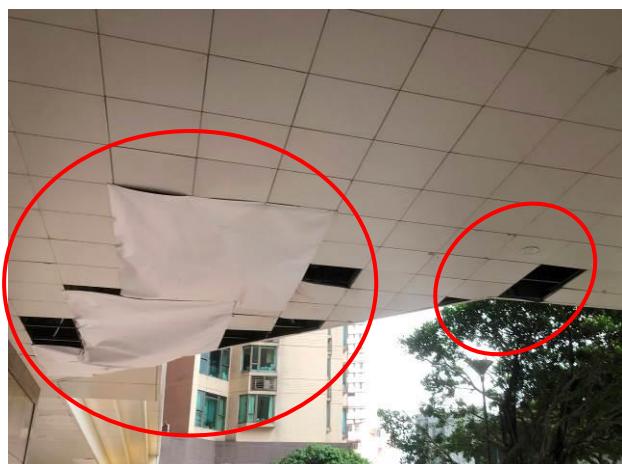
Photo No. B47 45 pieces of ceiling panel were missing.

Patch repair should be treated as the short-term remedial measure of the entire maintenance works. As the Ceiling System is a closed space design, missing ceiling panels would form gaps and reduce the effectiveness to withstand strong wind. The undermentioned approaches would spend much more time and it is not an easy way to solve the root cause. The Pacific Typhoon Season would approach in summer and there is an urgent need to replace and install new aluminum ceiling panels to seal the gaps.

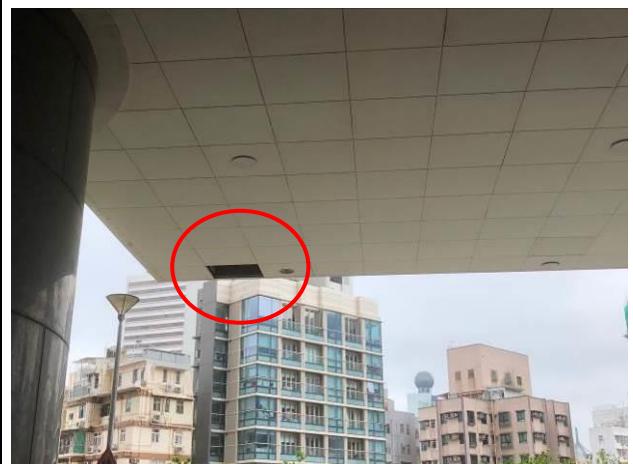
Photo No. B48 1 piece of ceiling panel was missing.

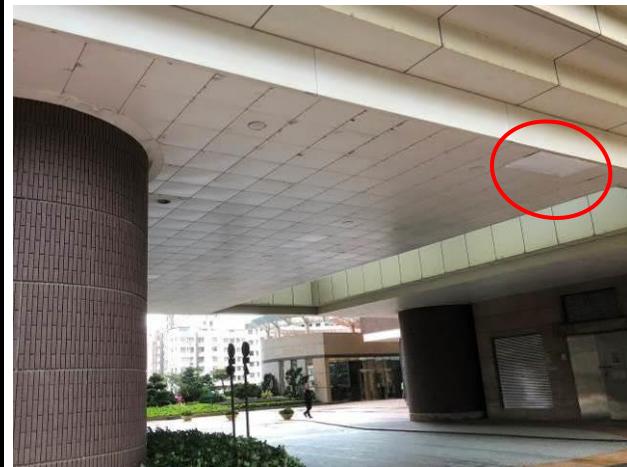
Photo No. B49 2 pieces of ceiling panel were missing.

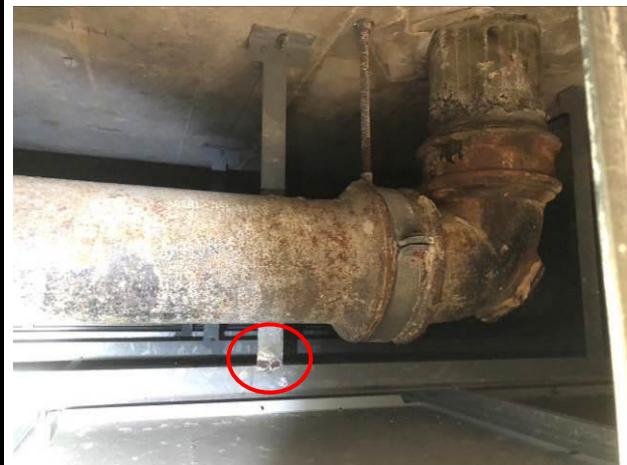
Photo No. B53 Welded joints were rusty.

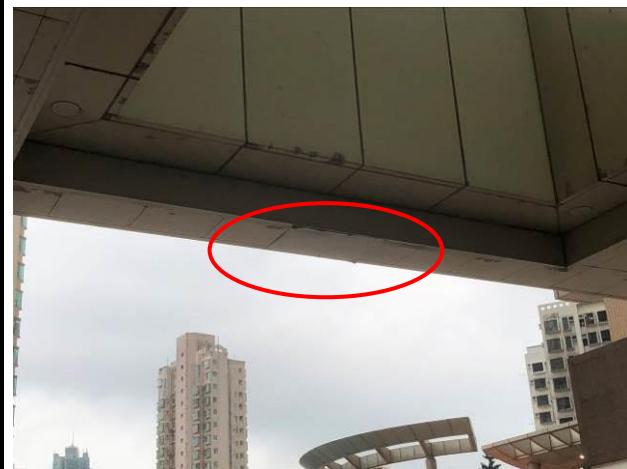
Photo No. B55 2 pieces of ceiling panel were missing.

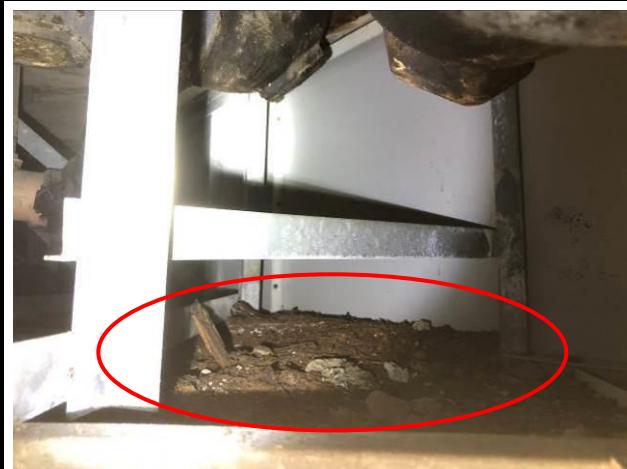
Photo No. B57 Debris was found on ceiling panels.

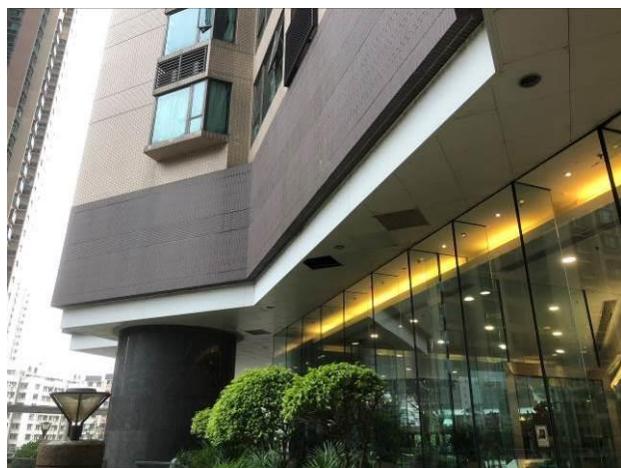
Photo No. B65 Area inaccessible scissor platform

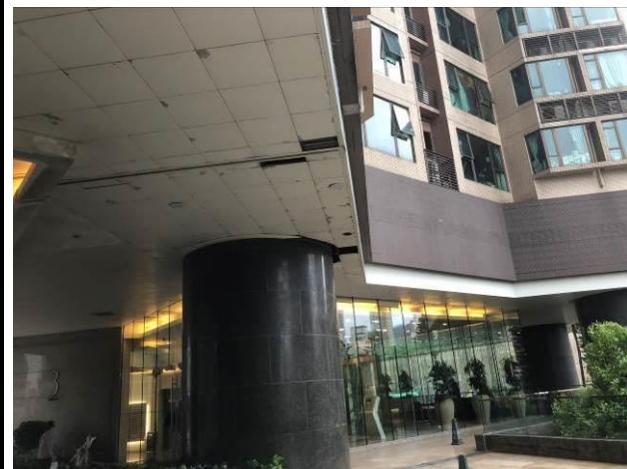
Photo No. B67 Area inaccessible area scissor platform

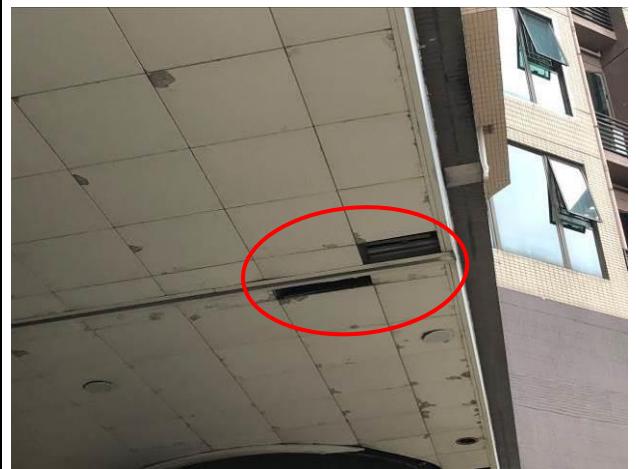
Photo No. B68 2 pieces of ceiling panel were missing.

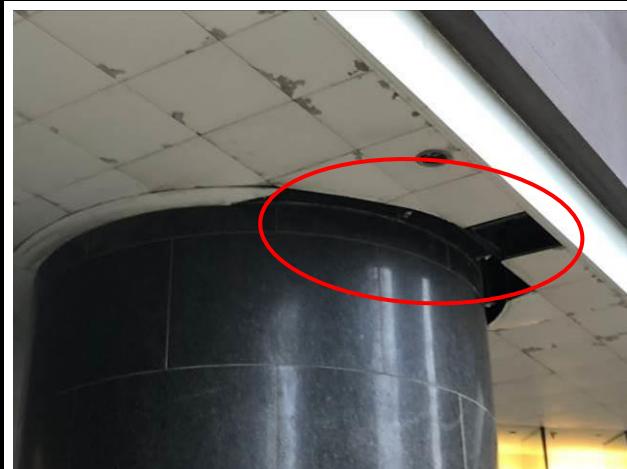
Photo No. B69 3 pieces of ceiling panel were missing.

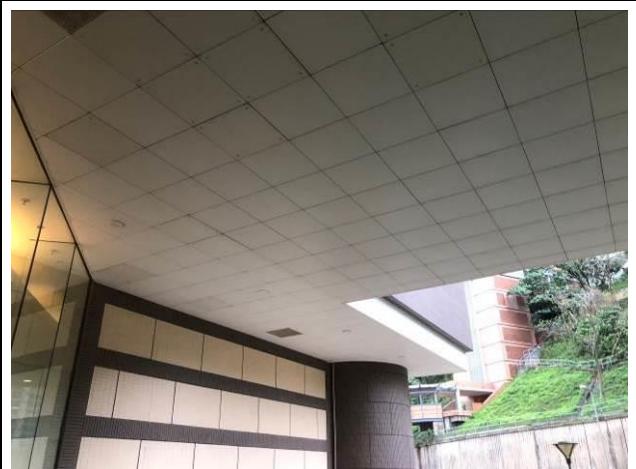
Photo No. B70 Area inaccessible area scissor platform.

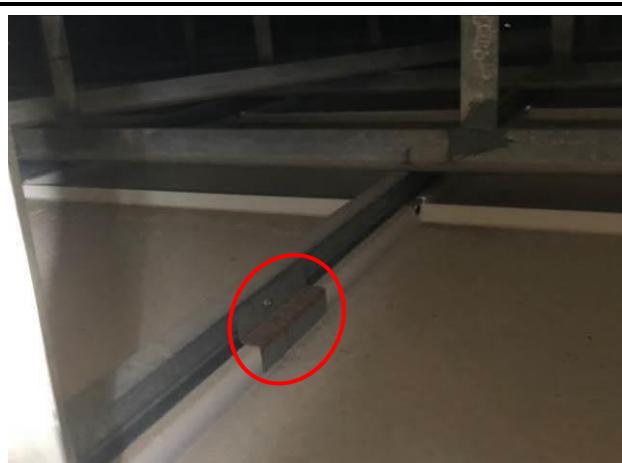
Photo No. C5 Bracket connecting grid and ceiling panel was rusty.

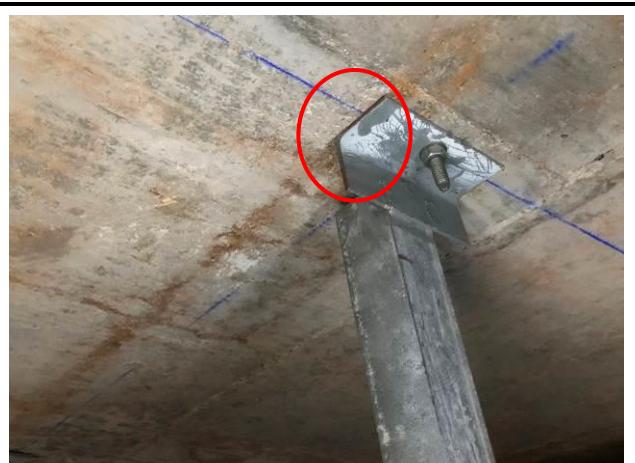
Photo No. C6 Edge of GMS plate was rusty

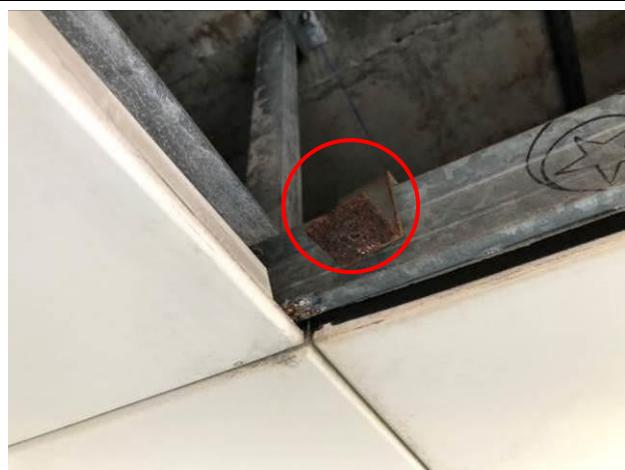
Photo No. C7

Bracket connecting grid and access panel was rusty.

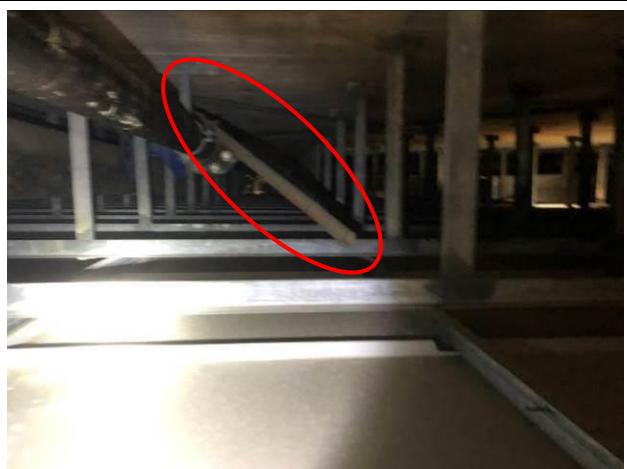
Photo No. C10

Debris was found on panels.

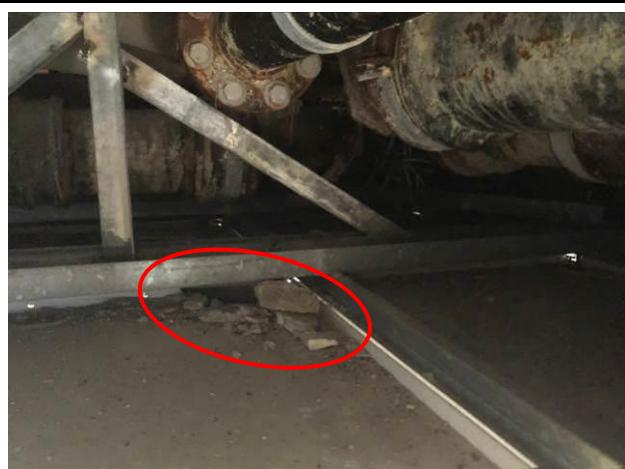
Photo No. C11

Debris was found on panels.

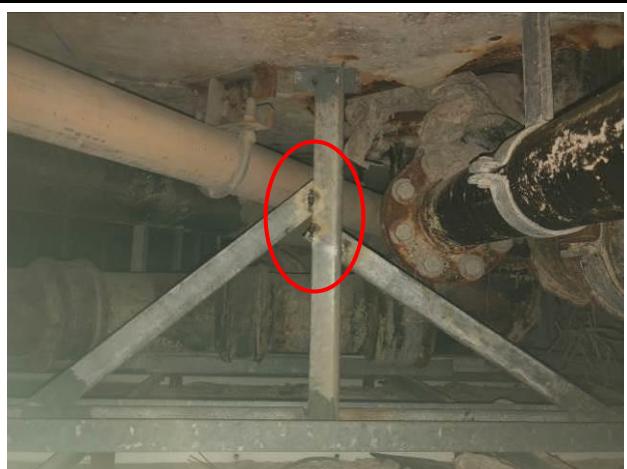
Photo No. C12

Welded joints were rusty.

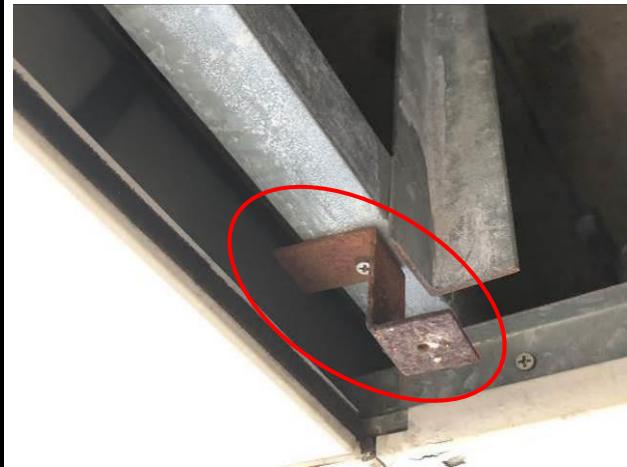
Photo No. C13 | Bracket connecting grid and access panel was rusty.

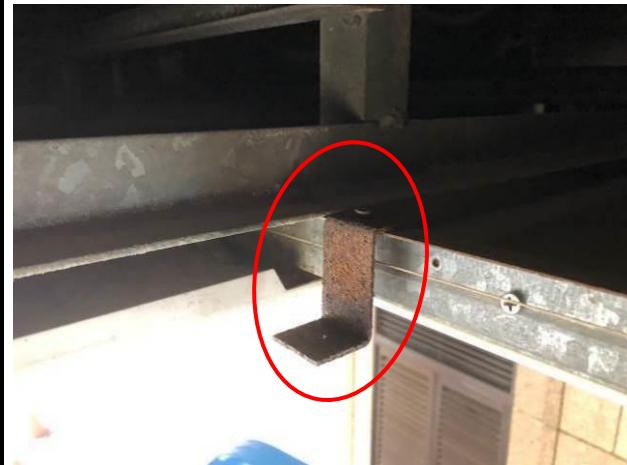
Photo No. C19 | Bracket connecting grid and access panel was rusty.

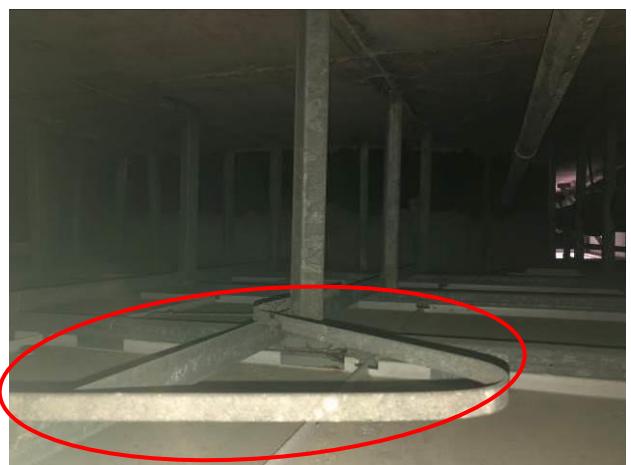
Photo No. C22 | Debris/ unused materials were found on panels.

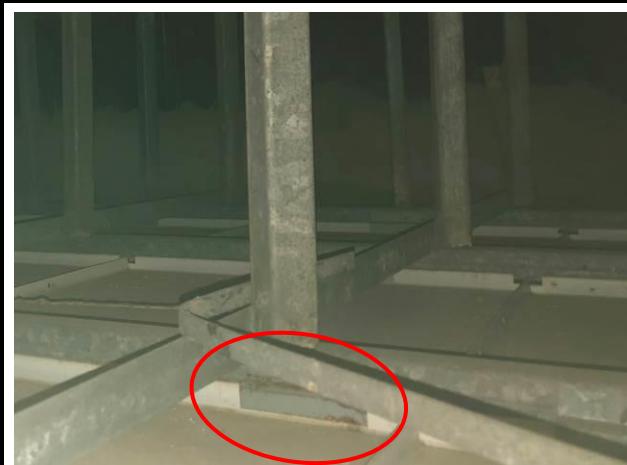
Photo No. C23 | Bracket connecting grid and ceiling panel was rusty.

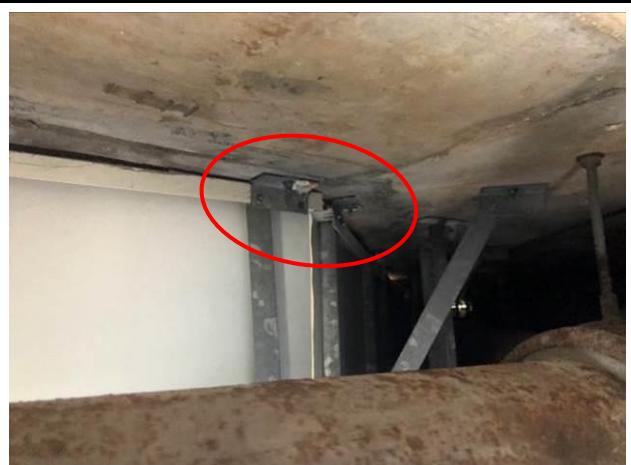
Photo No. C24 | GMS plates were rusty.

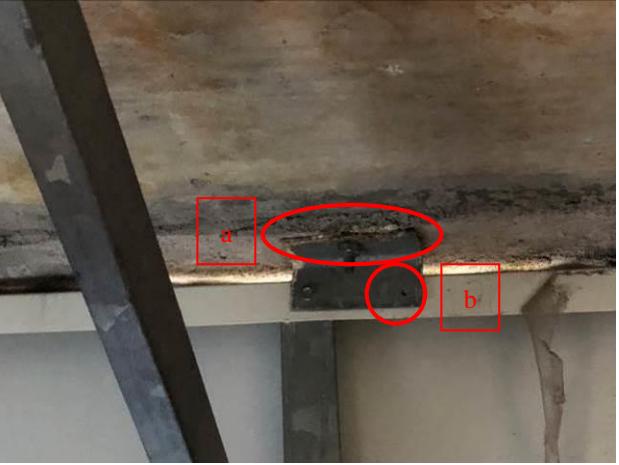
Photo No. C25	General view	Photo No. C26	a) GMS plate was rusty. b) Screws were missed.

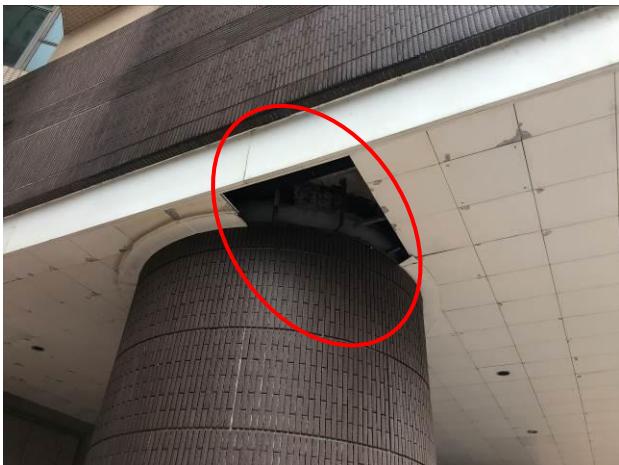
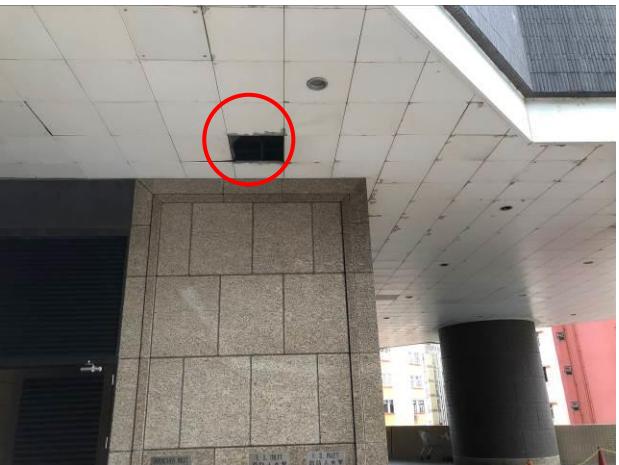
Photo No. C27	4 pieces of ceiling panels were missing.	Photo No. C28	1 piece of ceiling panel was missing.

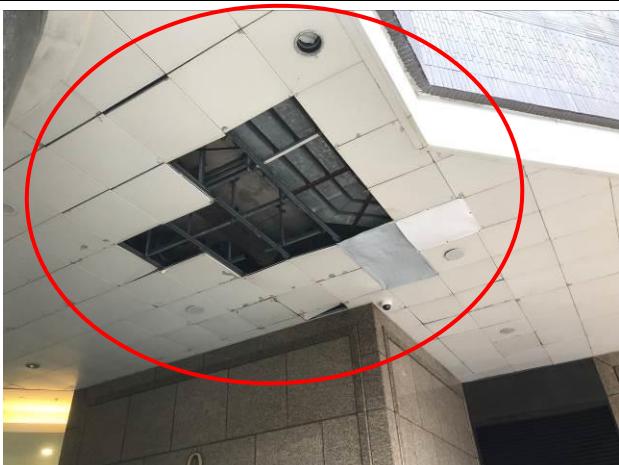
Photo No. C29	13 pieces of ceiling panel were missing and the surrounding panels were loosening.	Photo No. C30	Access point 5

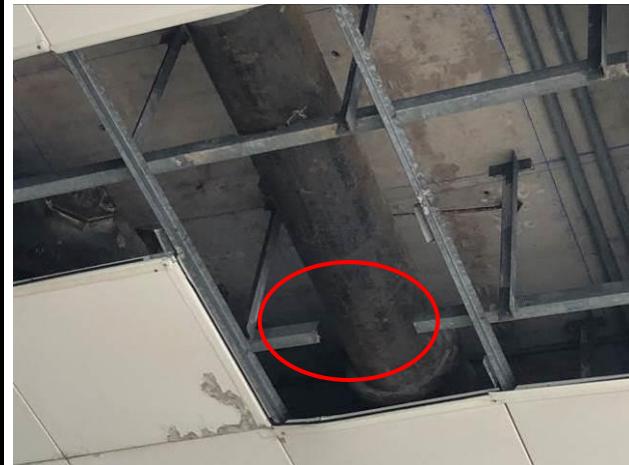
Photo No. C31 Ceiling grid was discrete.

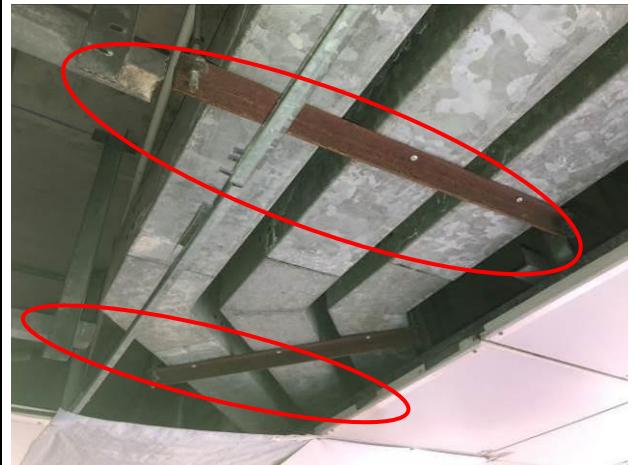
Photo No. C32 Ceiling grids were discrete.

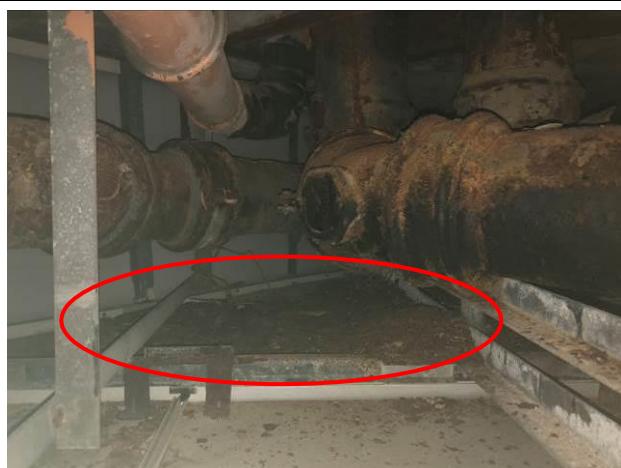
Photo No. C37

Debris was found on panels.

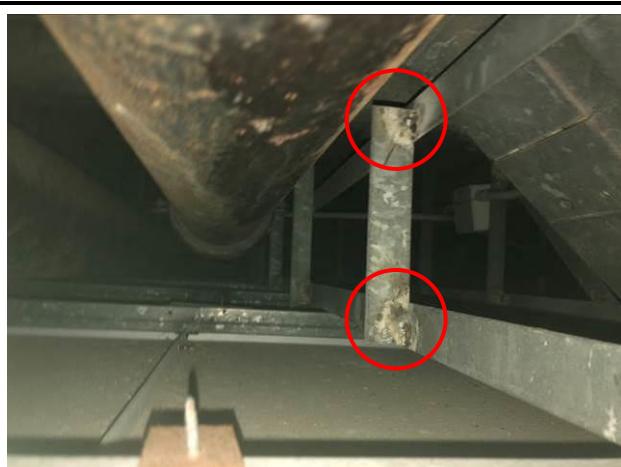
Photo No. C39

Welded joints were rusty.

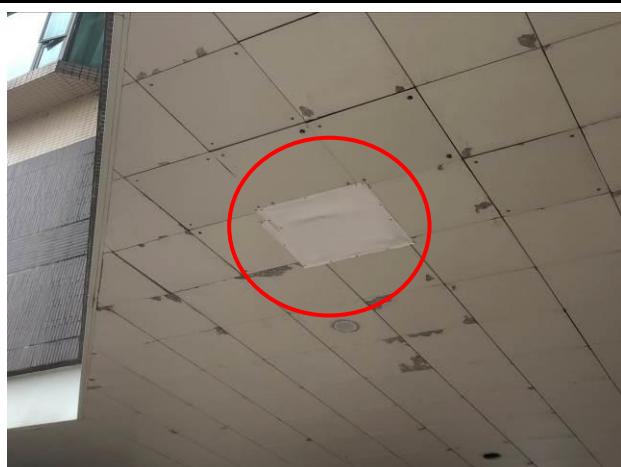
Photo No. C41

1 piece of ceiling panel was missing.

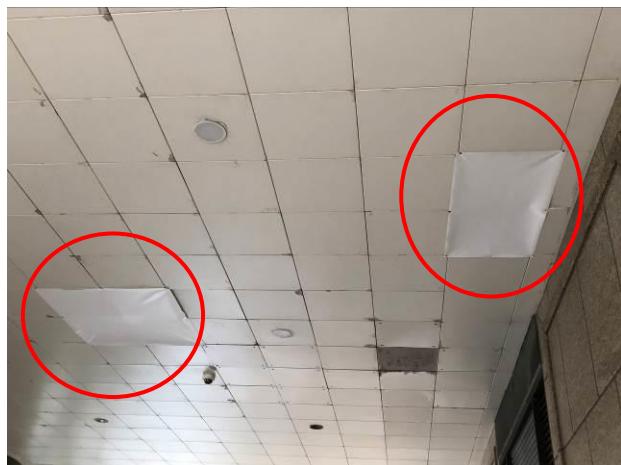
Photo No. C43

6 pieces of ceiling panels were missing.

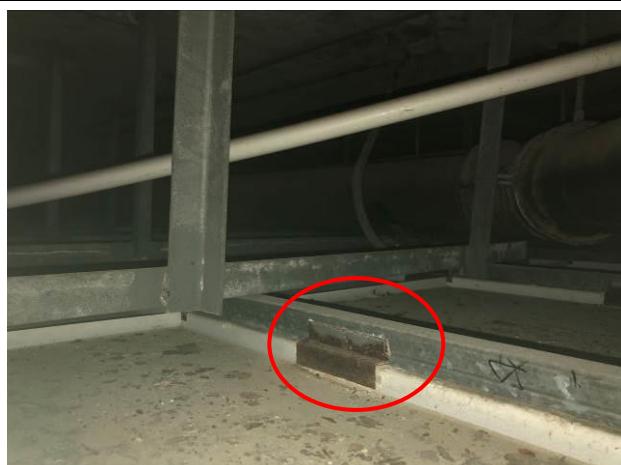
Photo No. C47

Bracket connecting grid and ceiling panel was rusty.

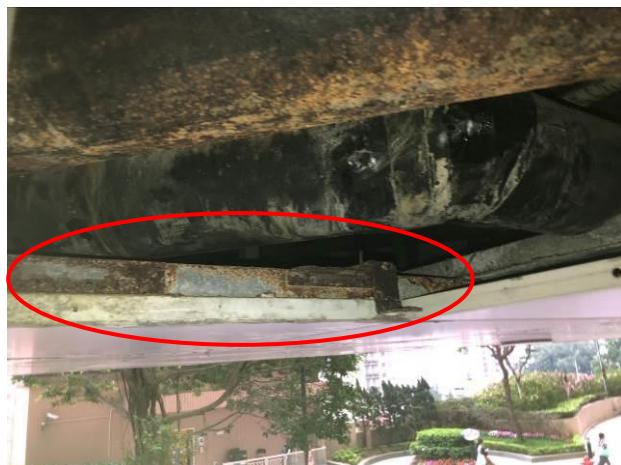
Photo No. C49

Ceiling grid was rusty.

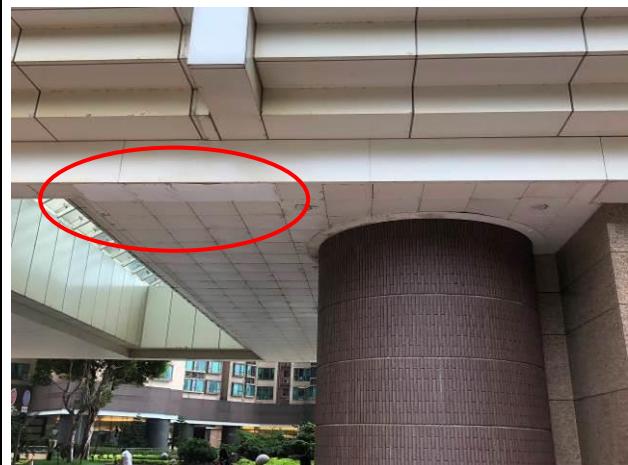
Photo No. C50

4 pieces of ceiling panels were missing.

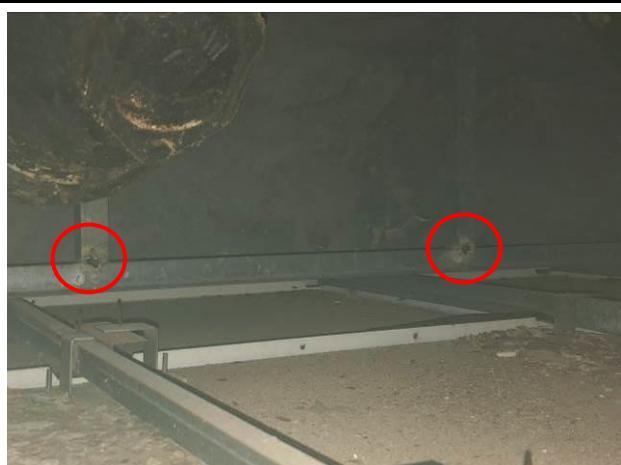
Photo No. C53

Welded joints were rusty.

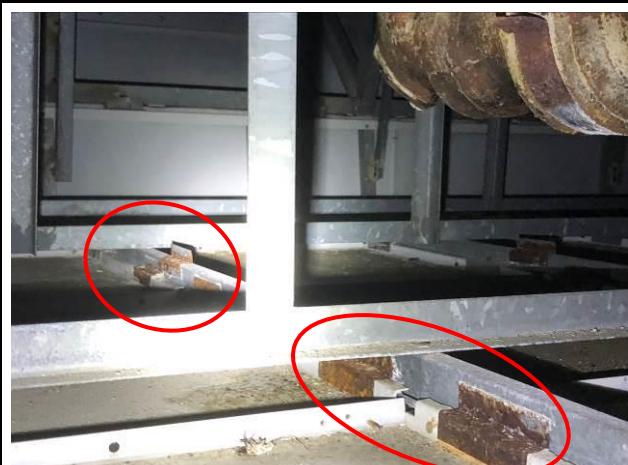
Photo No. C54

Brackets connecting grid and ceiling panel were rusty.

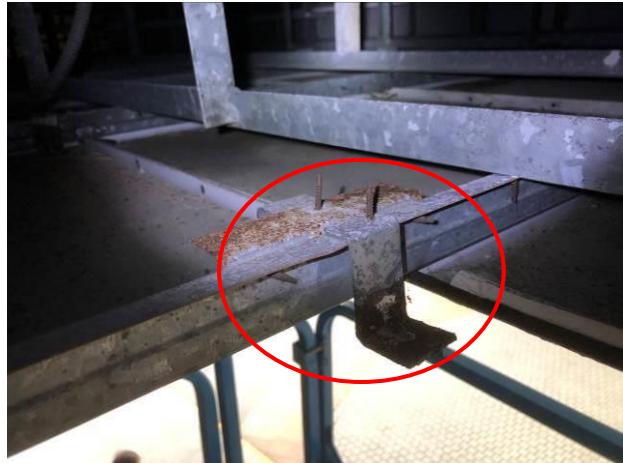
Photo No. C55 | Bracket connecting grid and access panel was rusty.

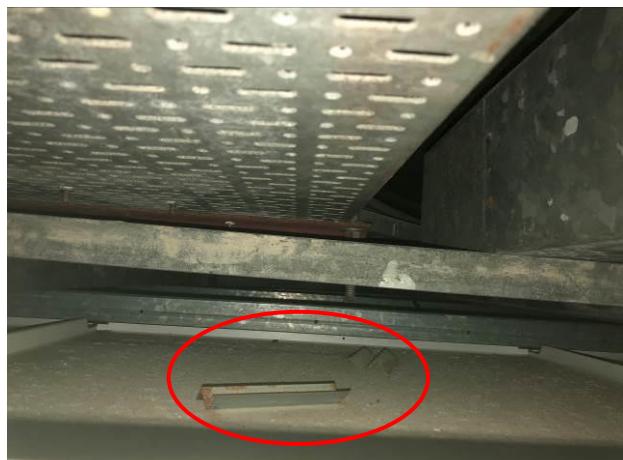
Photo No. C57 | Unused materials were found on panels.

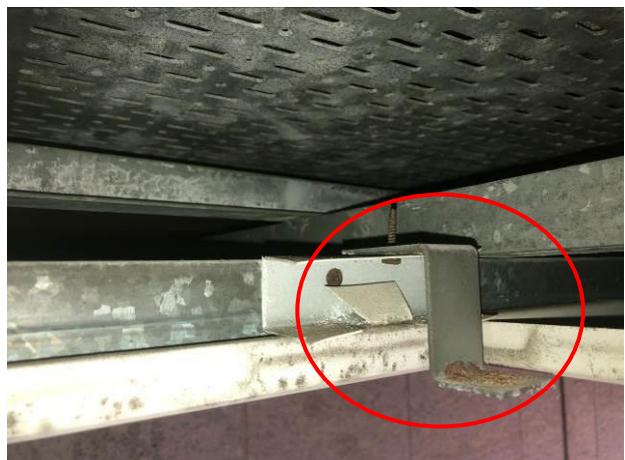
Photo No. C58 | Bracket connecting grid and access panel and screws were rusty.

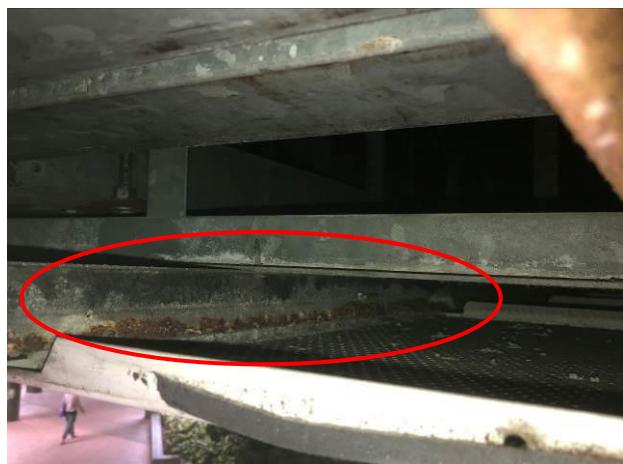
Photo No. C59 | Ceiling grid was rusty.

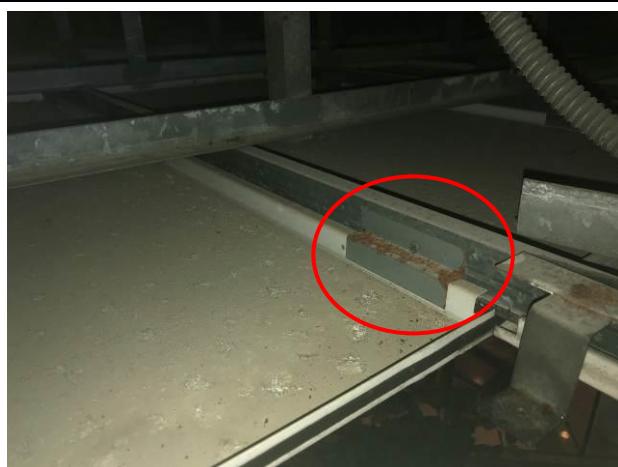
Photo No. C63 Bracket connecting grid and access panel was rusty.

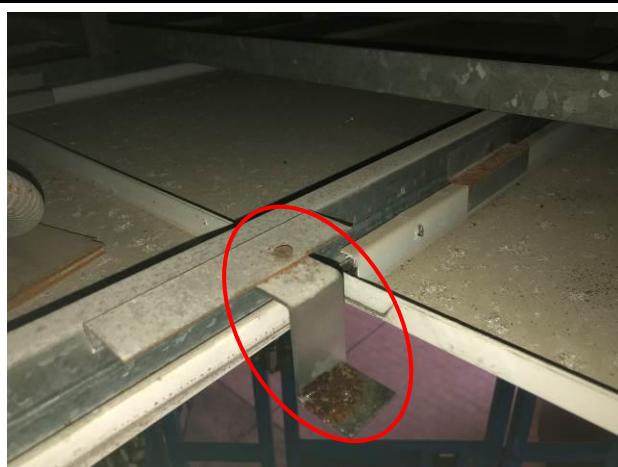
Photo No. C65 Bracket connecting grid and access panel and screw were rusty.

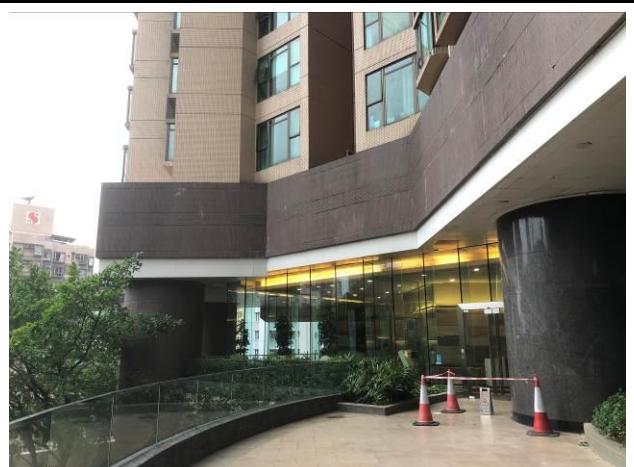
Photo No. C66 Area inaccessible area scissor platform.

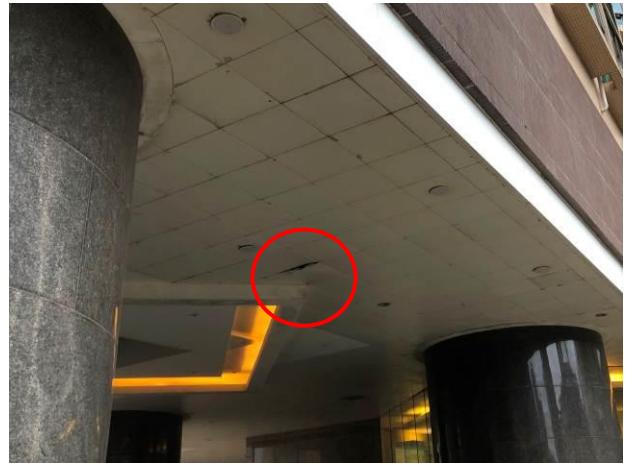
Photo No. C68 Damaged ceiling panel forming gap.
